March 16, 2023

Subject: Maintenance and Condition Assessment Report

FCC Designation	ASR Number:	1046007
MPB Designation:	MPB Site Name:	WMPN
Inspection Firm Designation:	TEP Project Number:	250673.814214
Site Data:	4700 Oakley-Palestine Road Raymond, MS 39170 (Hinds County) Latitude N 32° 11' 30.44", Longitude W 90° 24' 22.55" 1510 Foot – Guyed Tower

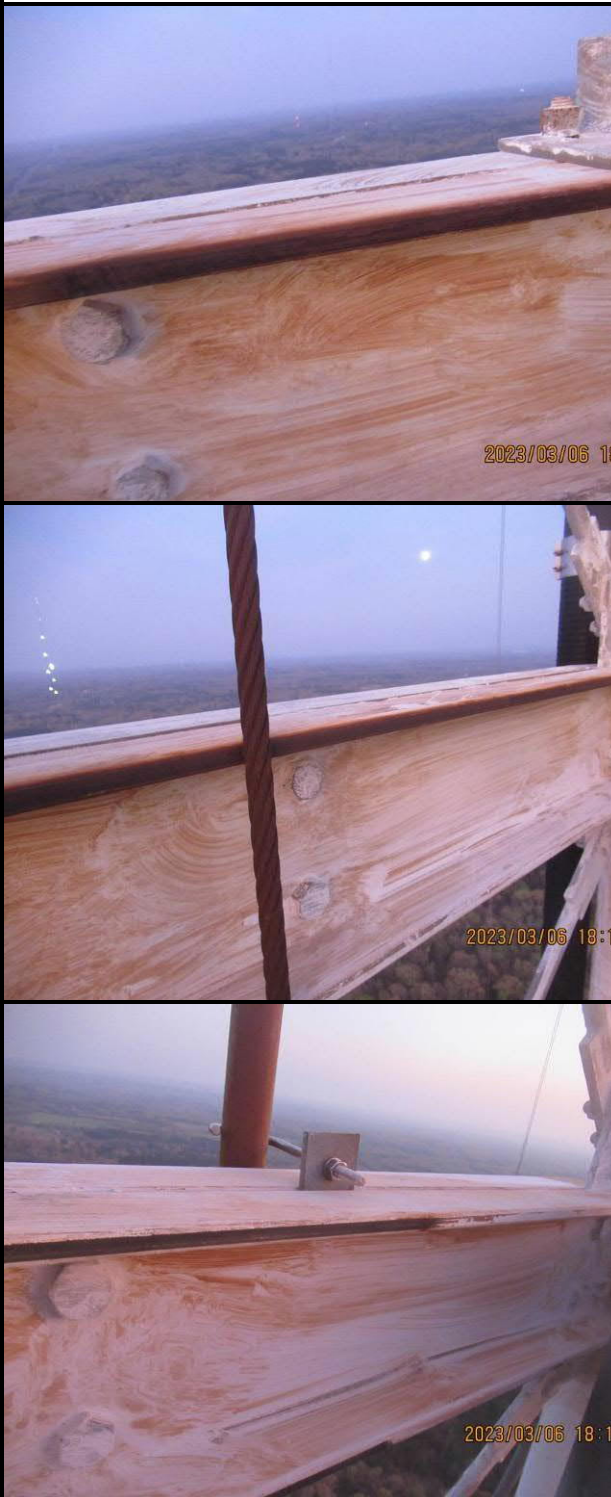
<p><u>B.2. Rust and/or corrosion condition including mounts and accessories</u></p> <p>Observation: Corrosion was observed on a horizontal brace at 879-ft due to an elevator cable rubbing against it.</p> <p>Recommendation: Thoroughly clean all areas of corrosion and apply two coats of a brush on cold galvanizing compound containing at least 95% zinc. A cable guide should be installed to prevent the elevator cable from rubbing against the member and causing further corrosion.</p>

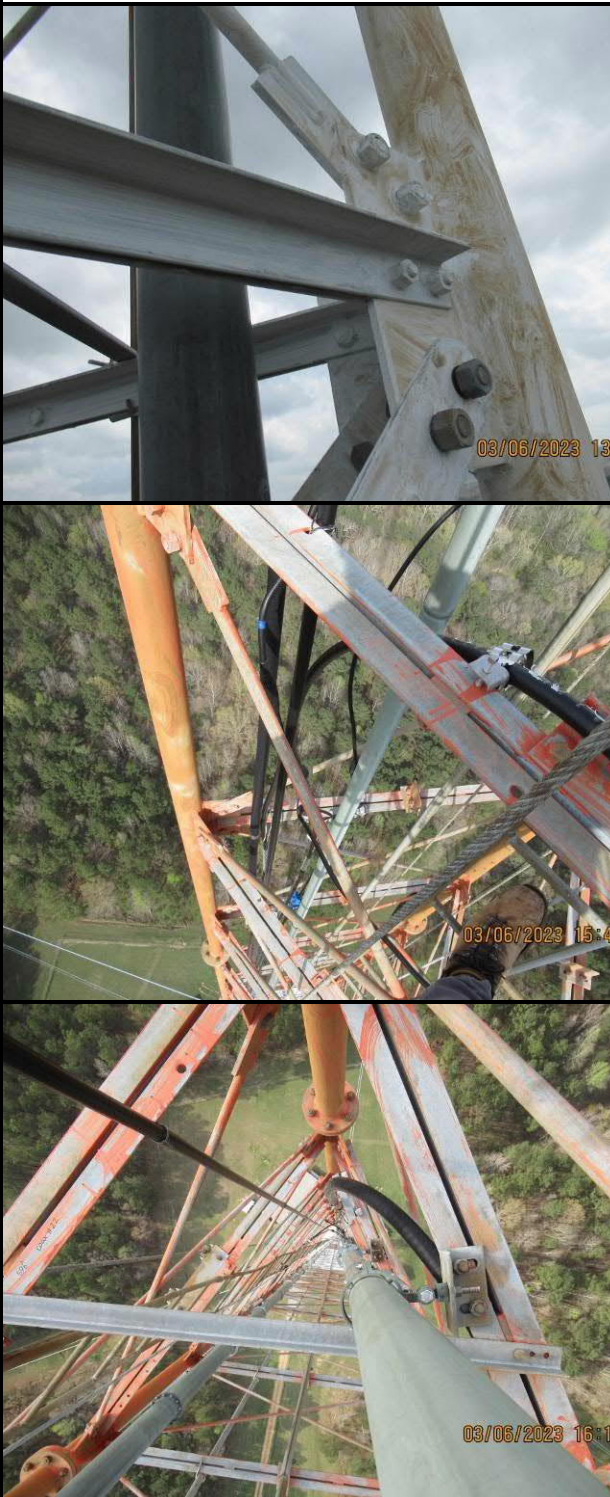
<p><u>B.3. FAA or ICAO color marking conditions</u></p> <p>Observation: The FAA paint is thin and weathered throughout the tower. The tower lights are functioning properly.</p> <p>Recommendation: Confirm tower marking requirements per FAA Advisory Circular AC70/7460-IM “Obstruction Marking and Lighting” and install appropriate tower lighting system. If tower marking is required, the structure and feedlines shall be re-painted to meet FAA requirements.</p>

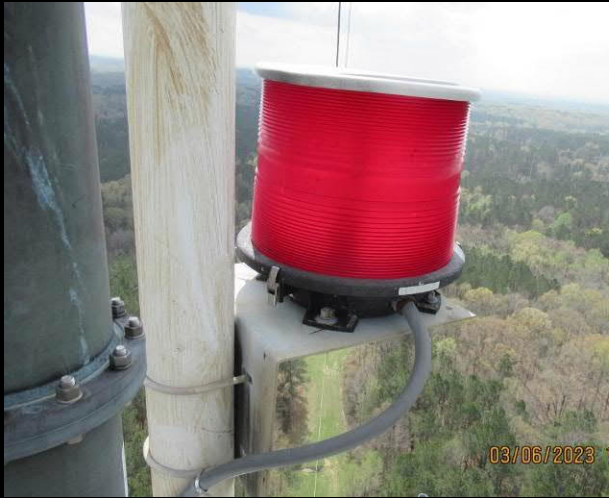
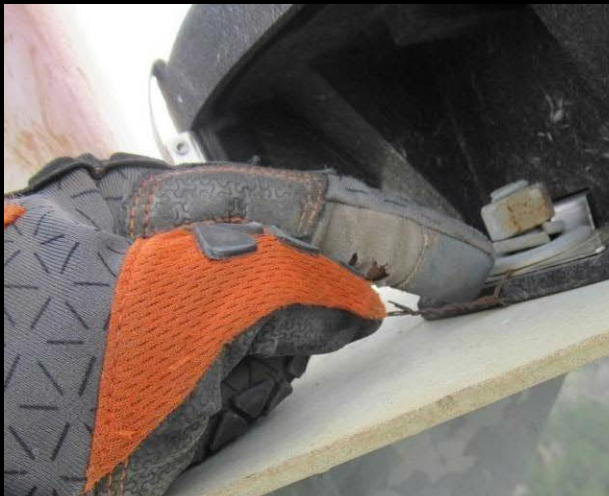
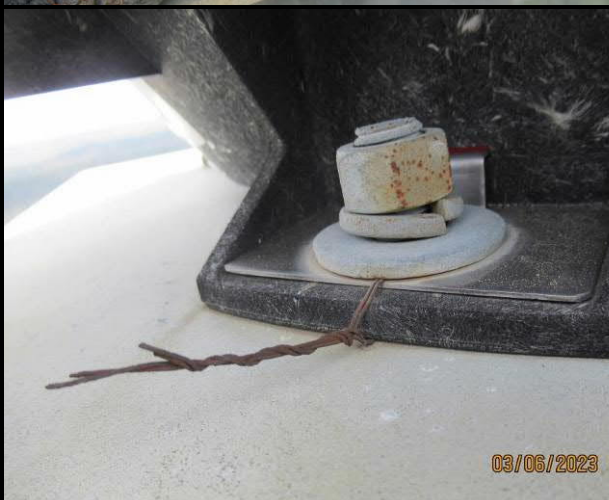
<p><u>C.1. Conduit, junction boxes, and fasteners (weather tight and secure)</u></p> <p>Observation: Loose mounting hardware was observed on at beacon at 340-ft.</p> <p>Recommendation: Tighten the loose nut until snug.</p>

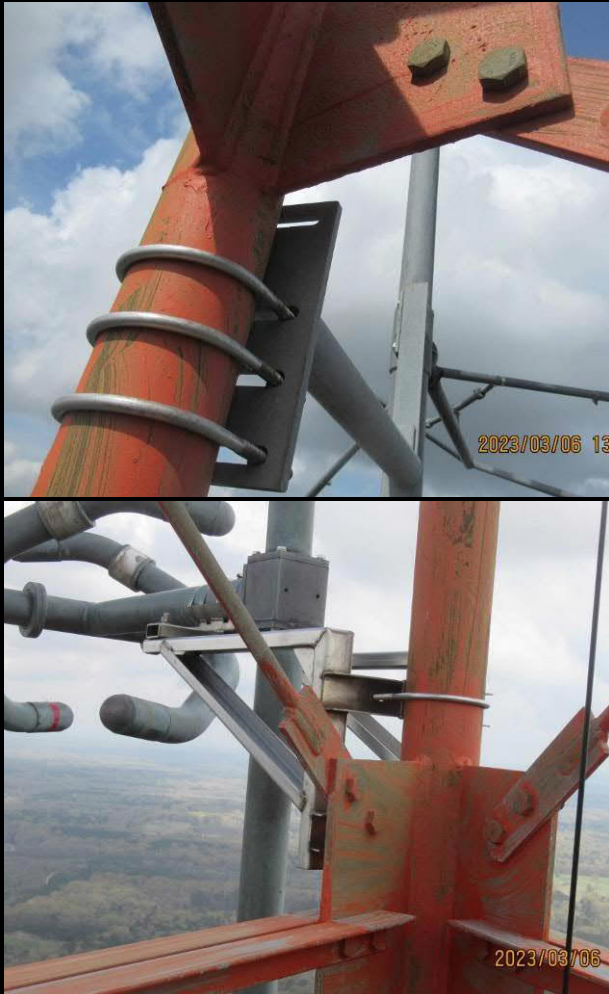
<p><u>E.1.d. Antenna and Mounts (Loose or missing hardware)</u></p> <p>Observation: A missing U-bolt was observed at approximately 1144-ft and 1333-ft for FM transmitter mounts, as there was interference with an existing gusset.</p> <p>Recommendation: Additional U-bolts should be installed in alternate location to ensure all antennas are properly secured.</p>

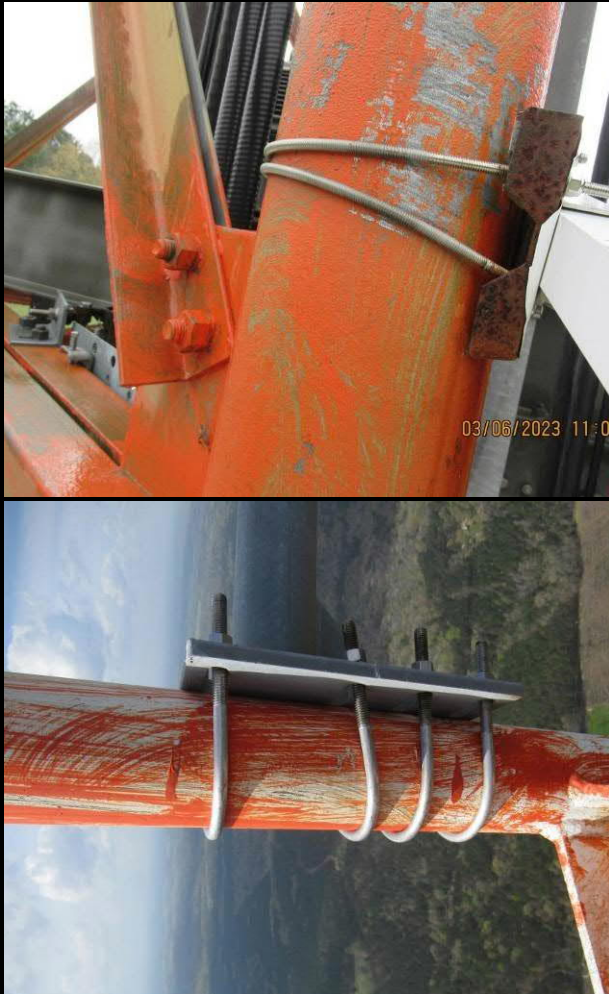
<p><u>E.1.d. Antenna and Mounts (Loose or missing hardware)</u></p> <p>Observation: Skewed mount U-bolts were observed on antenna 1 at 26-ft and on an FM 1363-ft.</p> <p>Recommendation: U-bolts should be installed level. If any damage has occurred due to improper installation, replace hardware.</p>

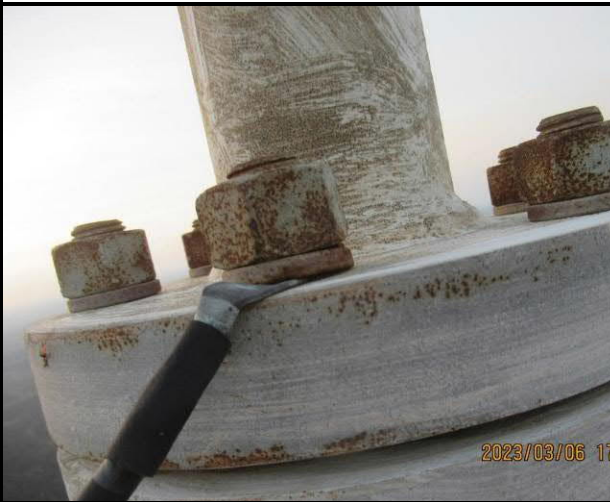
<p><u>E.2.a. Feed line condition (flanges, seals, dents, jacket damage, grounding, etc.)</u></p> <p>Observation: A ground at 1010-ft was installed incorrectly beneath an A-leg flange bolt. This also prevents the flange bolt from being fully engaged.</p> <p>Recommendation: Reinstall ground in alternate location. Ensure flange bolt is tightened as per AISC turn of the nut method.</p>

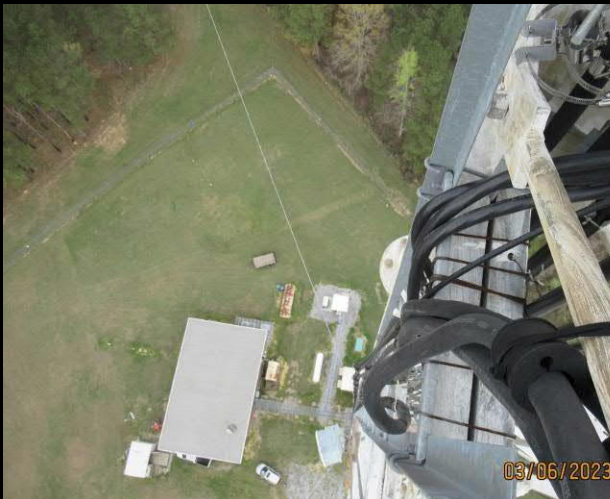
<p><u>E.2.b. Feed Lines (Properly secured/supported on the structure and mount)</u></p> <p>Observation: Moderate corrosion was observed on the feedline hangers at 299-ft.</p> <p>Recommendation: Notify the carrier of the existing conditions. All feedlines should be secured to the structure with proper coax hangers with connections spaced per the manufacturer's specifications.</p>

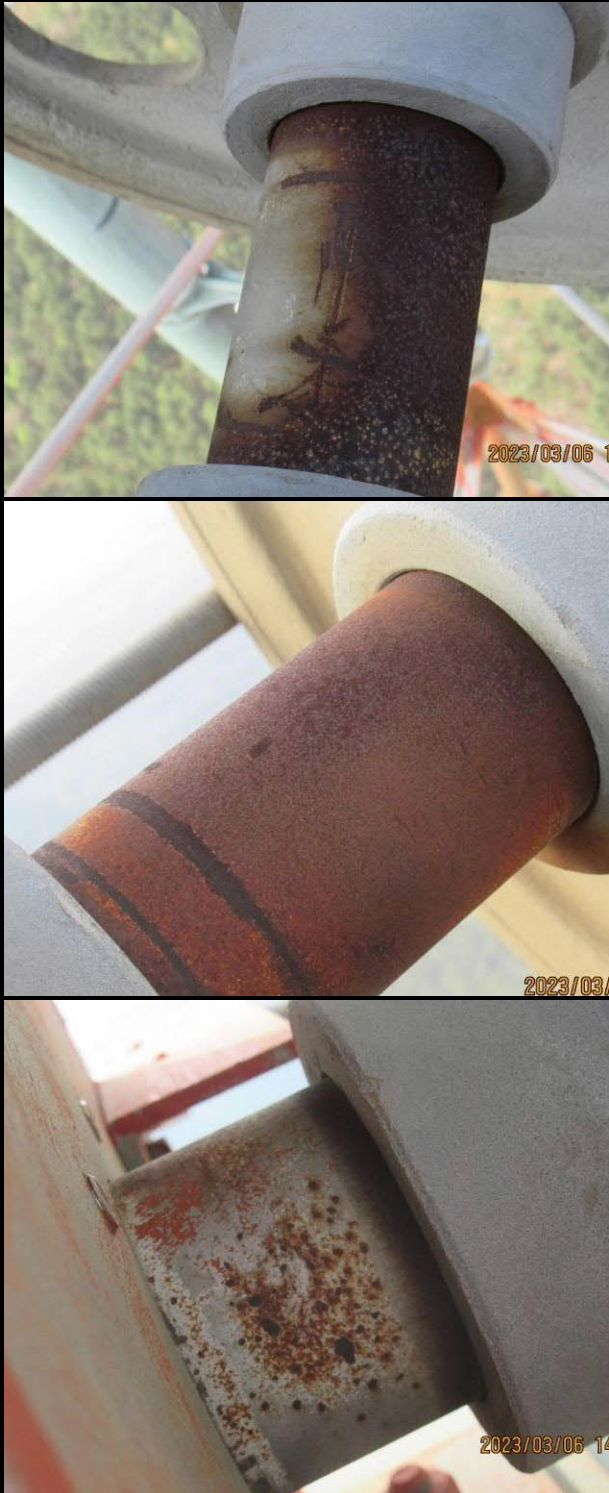
<p><u>F.1. Condition</u></p> <p>Observation: Corrosion was observed on the axle associated with elevator cable pulleys.</p> <p>Recommendation: Thoroughly clean all areas of corrosion and apply two coats of a brush on cold galvanizing compound containing at least 95% zinc. If during this process any material loss is observed, replace the axle and ensure proper function. Ensure all equipment is properly lubricated to maintain safe function of elevator.</p>

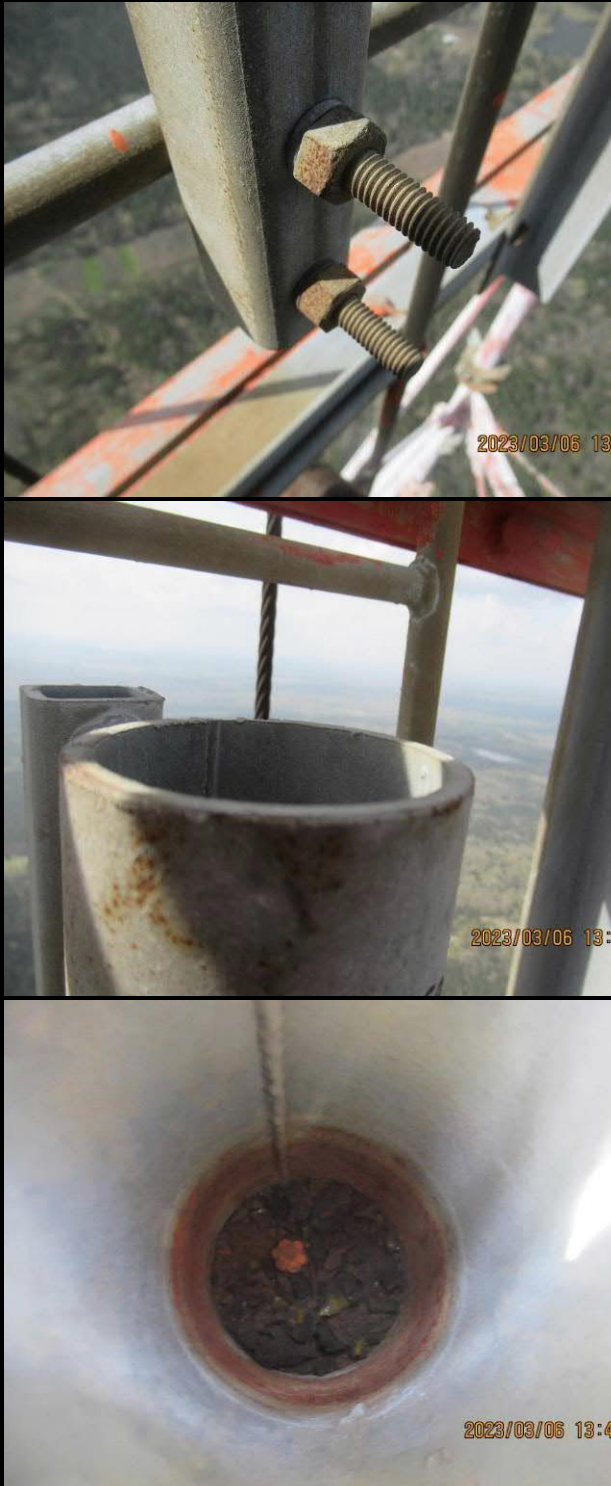
<p>The first photograph shows a close-up of a metal joint with two bolts. The bolts and surrounding metal show signs of corrosion. A timestamp '2023/03/06 13:4' is visible in the bottom right corner.</p> <p>The second photograph shows a large, cylindrical metal cup or container. It appears to be part of the tower structure. A timestamp '2023/03/06 13:4' is visible in the bottom right corner.</p> <p>The third photograph shows a circular opening in a metal surface, looking down into a dark, possibly debris-filled cavity. A timestamp '2023/03/06 13:4' is visible in the bottom right corner.</p>	<p><u>F.2. Obstructions to climbing path or safety climb systems</u></p> <p>Observation: The following issues were observed with the safety climb #2 top termination at 1465-ft:</p> <ul style="list-style-type: none"> • no cap • bolt surface corrosion • severe corrosion within the strandvice <p>Recommendation: Tag out and discontinue use of the safety climb system until it can be replaced.</p>

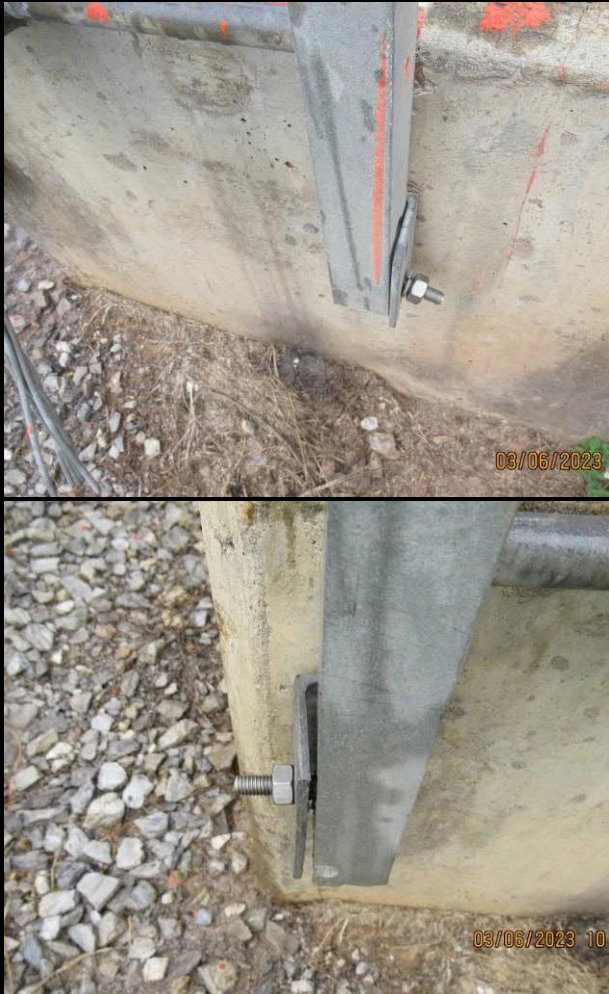
<p><u>F.2. Obstructions to climbing path or safety climb systems</u></p> <p>Observation: The bottom ladder connection bolts at the base of the tower are loose.</p> <p>Recommendation: Tighten loose nuts until snug.</p>

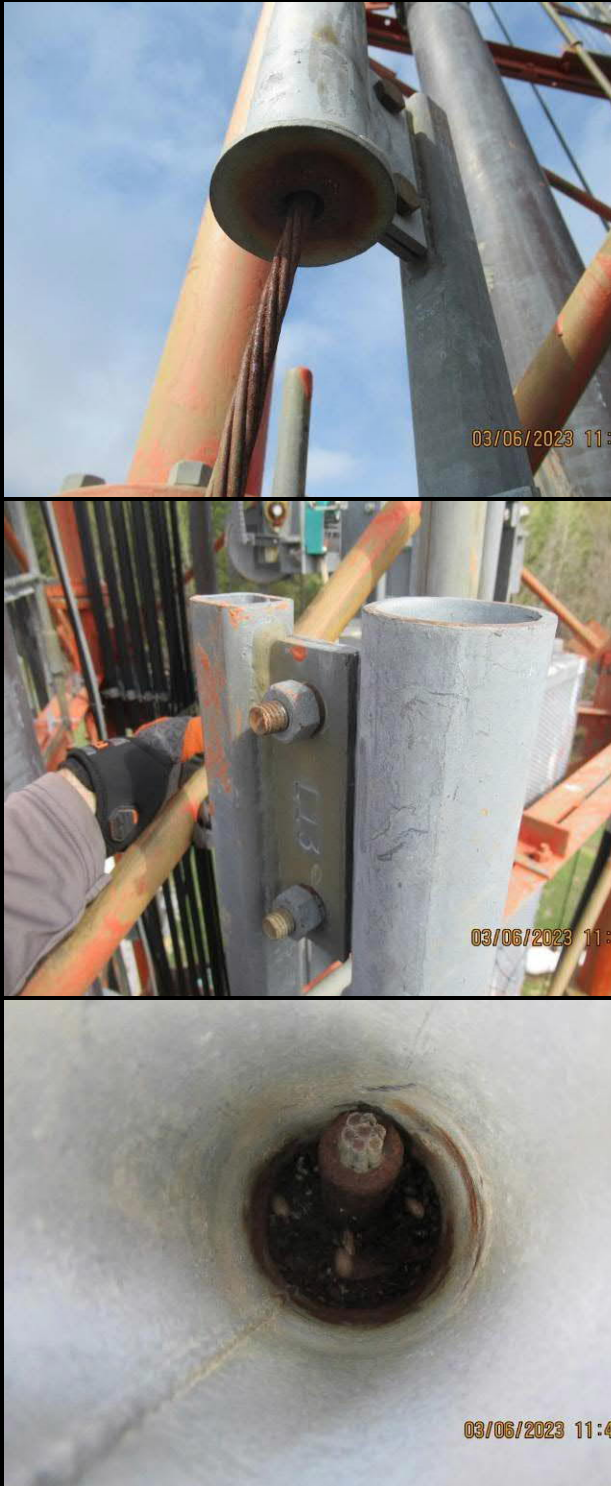
<p>The first photograph shows a close-up of a cable termination on a tower leg, with a timestamp of 03/06/2023 11:4. The second photograph shows a bolted joint on a tower leg, with a timestamp of 03/06/2023 11:4. The third photograph shows a close-up of a bolt head inside a circular opening, with a timestamp of 03/06/2023 11:4.</p>	<p><u>F.2. Obstructions to climbing path or safety climb systems</u></p> <p>Observation: The following issues were observed with the safety climb #1 top termination at 50-ft:</p> <ul style="list-style-type: none"> • no cap • bolt surface corrosion • cable corrosion • debris within the upper termination • corrosion within the upper termination <p>Recommendation: Tag out and discontinue use of the safety climb system until it can be replaced.</p>

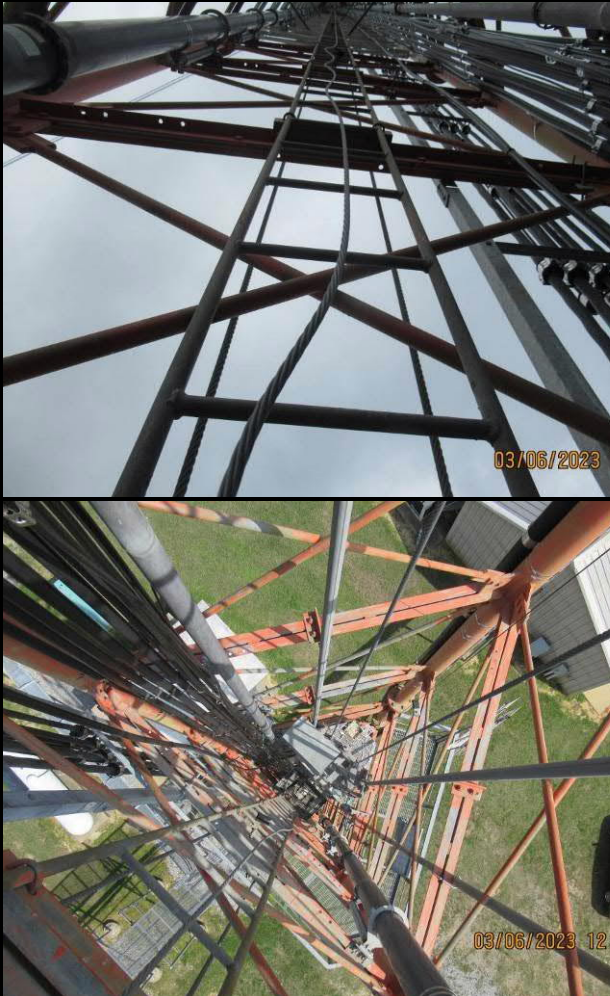
<p><u>F.2. Obstructions to climbing path or safety climb systems</u></p> <p>Observation: The cable for safety climb #2 is loose, and several kinks were observed..</p> <p>Recommendation: Tighten the tension adjustment bolt at the bottom termination to remove the excess slack in the safety cable.</p>

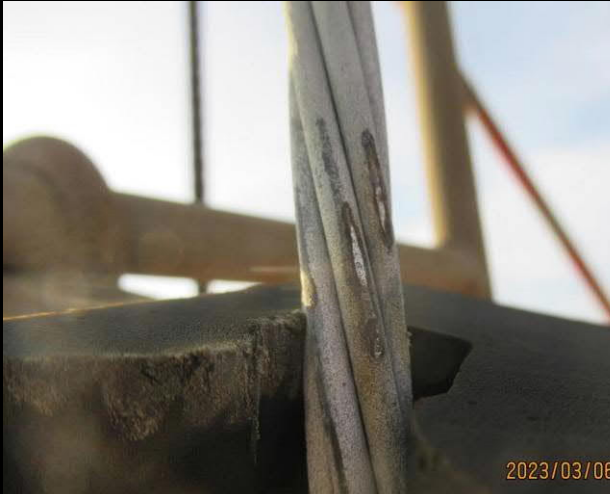
<p><u>F.2. Obstructions to climbing path or safety climb systems</u></p> <p>Observation: Safety cable material loss was observed at 1315-ft.</p> <p>Recommendation: Tag out and discontinue use of the safety climb system until it can be replaced.</p>

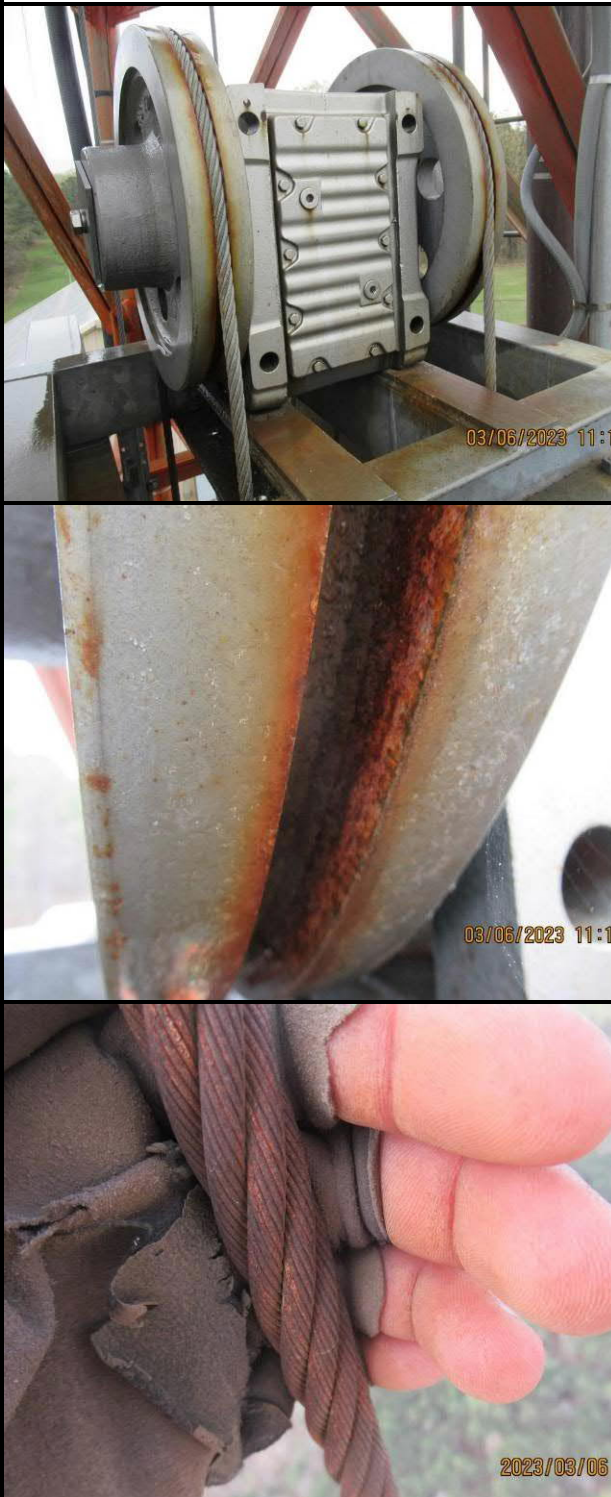
<p><u>F.3. Other Appurtenances (Defects, deformations, loose, or missing members, etc.)</u></p> <p>Observation: The elevator pulleys and cables exhibit moderate corrosion.</p> <p>Recommendation: Elevator equipment should be inspected and serviced by a licensed technician prior to being placed back into service.</p>

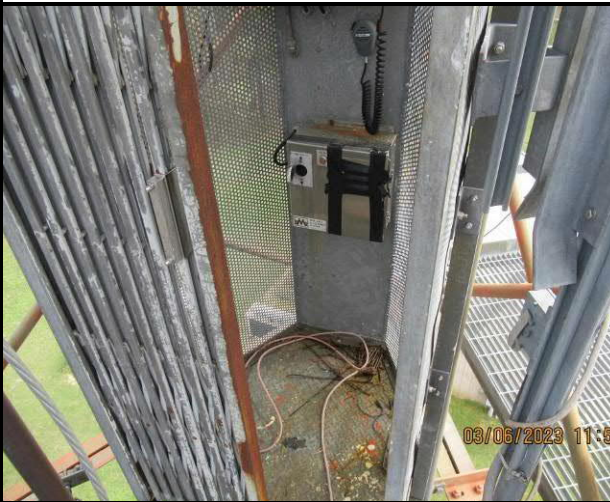
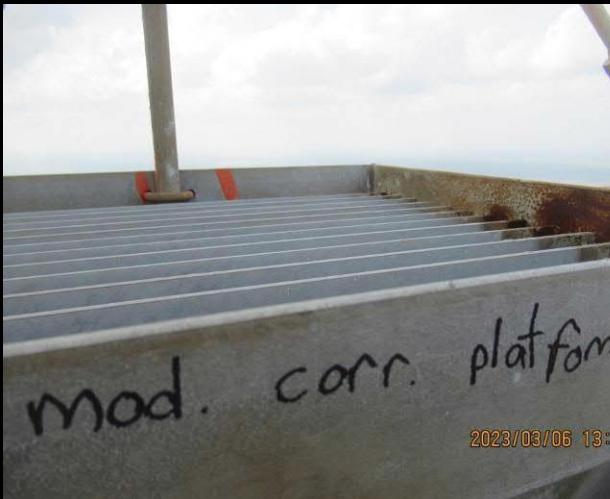
<p><u>F.3. Other Appurtenances (Defects, deformations, loose, or missing members, etc.)</u></p> <p>Observation: Corrosion was observed on the elevator door, as well as elevator platforms throughout.</p> <p>Recommendation: Thoroughly clean all areas of corrosion and apply two coats of a brush on cold galvanizing compound containing at least 95% zinc.</p>

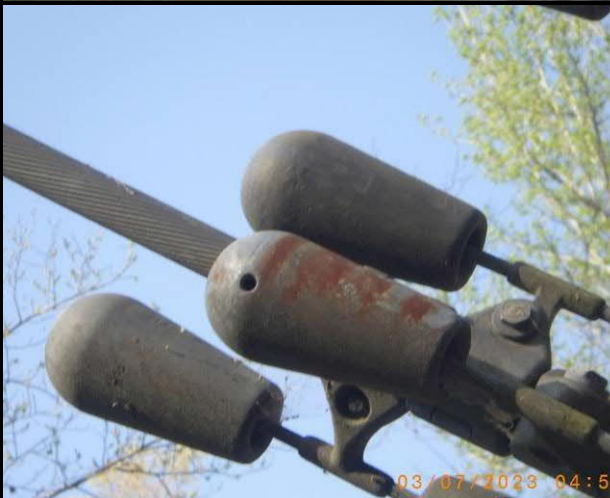
<p><u>H.2.d.vi. Guy Hardware Conditions (Cable connectors (Shackles, bolts, pins, and cotter pins secure and in good condition))</u></p> <p>Observation: Corrosion was observed on a guy dampener at guy level 6 at the BB anchor.</p> <p>Recommendation: Thoroughly clean all areas of corrosion and apply two coats of a brush on cold galvanizing compound containing at least 95% zinc. If during this process any material loss is observed, replace the dampener and ensure proper function.</p>

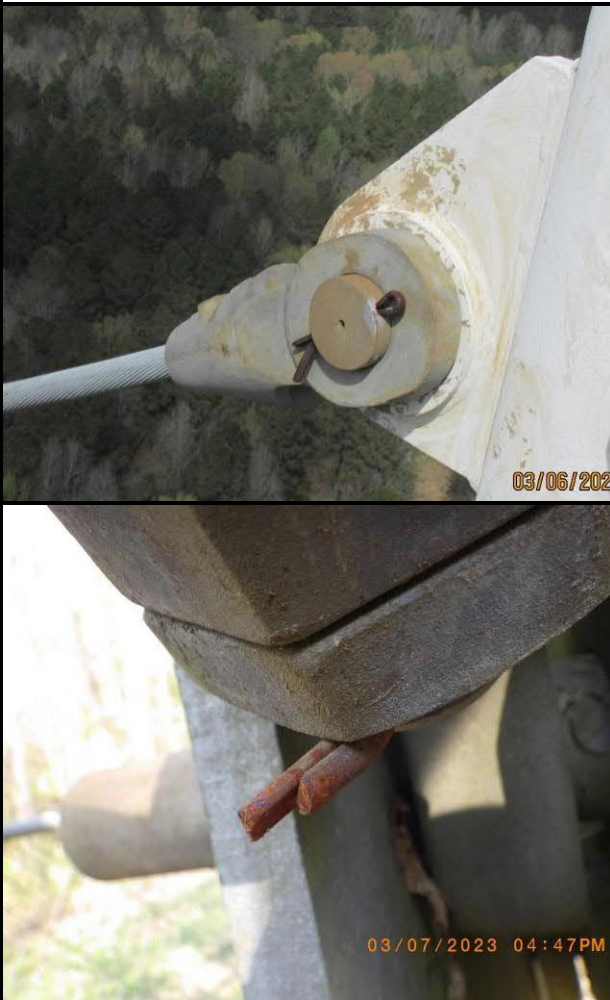
<p><u>H.2.d.vi. Guy Hardware Conditions (Cable connectors (Shackles, bolts, pins, and cotter pins))</u></p> <p>Observation: Moderate corrosion observed on cotter pins at all guy levels throughout the tower and ground anchors.</p> <p>Recommendation: Replace the corroded cotter pins.</p>

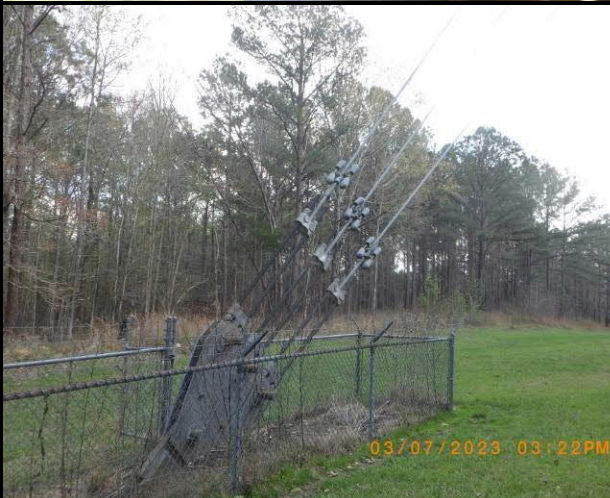
<p><u>H.3.a. Measure guy tensions</u></p> <p>Observation: Guy tensions are not within the allowable limits. See Appendix B for locations and recommendations. Guy level 2 and 4 tension tags are mislabeled at C anchor.</p> <p>Recommendation: Re-tension the guy wires to within recommended limits while ensuring twist and plumb are also within recommended limits. Swap tension tags at C anchor to accurately reflect initial tensions.</p>

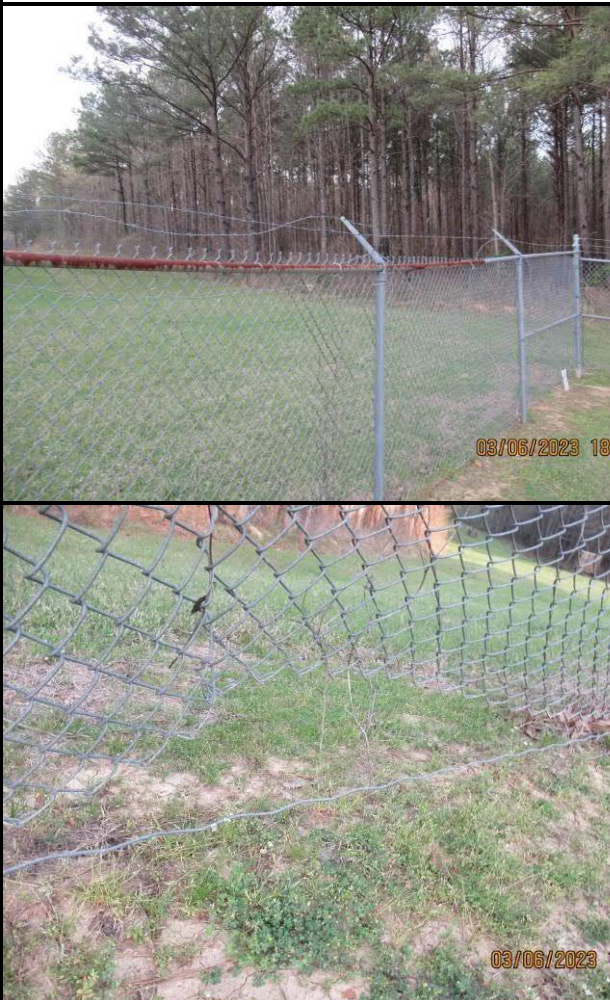
<p><u>I.1.c. Ground condition (Site condition (standing water, drainage, trees, etc.))</u></p> <p>Observation: The compound fence is damaged in the North and East corners.</p> <p>Recommendation: Repair the damaged areas of the fence.</p>

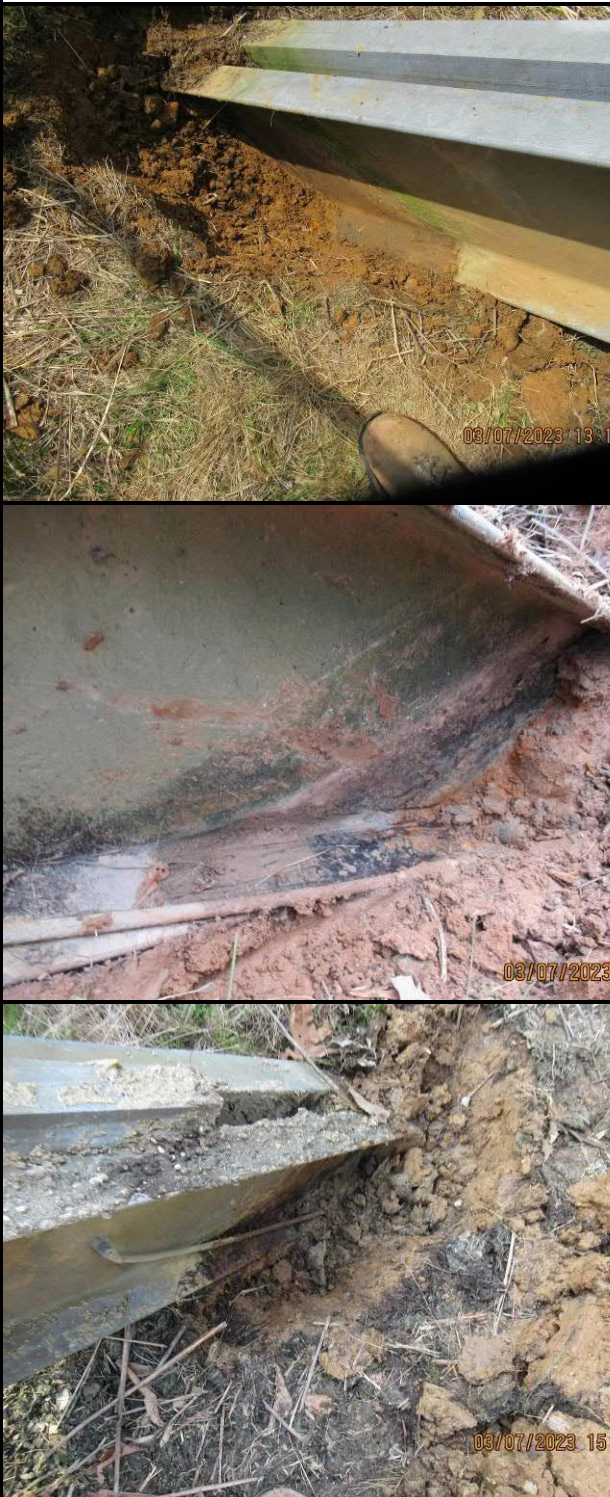
<p><u>J.3. Guy Mast Anchors (Anchor shaft condition below grade)</u></p> <p>Observation: Surface corrosion below grade was observed at the following anchors:</p> <ul style="list-style-type: none"> • AA • B • BB • C • CC <p>Recommendation: Anchor shafts should be excavated down to top of concrete, cleaned, and material loss measured to determine extent of damage. A protective coating should be applied to the anchor shafts prior to backfilling and a cathodic protection system should be installed to prevent further corrosion. For exposed steel above grade, thoroughly clean all areas of corrosion and apply at least two coats of a cold galvanizing compound containing at least 95% zinc. Areas of material loss should be measured to determine extent of damage.</p> <p>Refer to the Nation Associated of Tower Erectors guideline “Inspection of Guy Anchors in Direct Contact with Soil.”</p>
