Tower Engineering Professionals, Inc.  
326 Tryon Road  
Raleigh, NC 27603  
(919) 661-6351  
[bhm\\_inspections@tepgroup.net](mailto:bhm_inspections@tepgroup.net)

**April 13, 2023**

**Subject: Maintenance and Condition Assessment Report – Revision 1**

<b>FCC Designation</b>	<b>ASR Number:</b>	1041044
<b>Client Designation:</b>	<b>Client Site Name:</b>	WMAV
<b>Inspection Firm Designation:</b>	<b>TEP Project Number:</b>	19780.814204
<b>Site Data:</b>	<b>Near CR344</b>	
	<b>Oxford, Lafayette County, MS 38655</b>	
	<b>Latitude N 34° 17' 28", Longitude W 89° 42' 21"</b>	
	<b>1250 Foot – Guyed Tower</b>

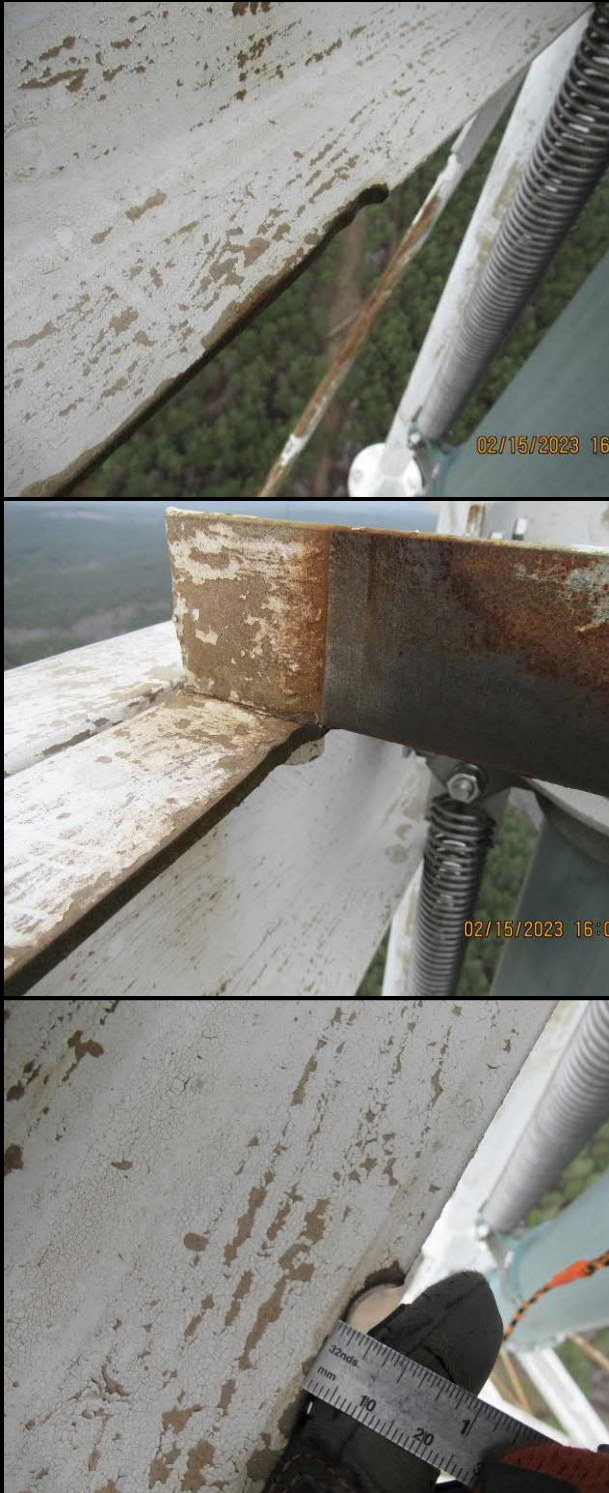
<p><b><u>A.1. Damaged members (legs and bracing)</u></b></p> <p><b>Observation:</b> Material loss and surface corrosion was observed inside C channel at all guy levels due to contact with elevator cables.</p> <p><b>Recommendation:</b> A structural engineer licensed in the state of Mississippi should review any areas of section loss to determine the appropriate course of action. Thoroughly clean all areas of corrosion and apply two coats of a cold galvanizing compound containing at least 95% zinc.</p>

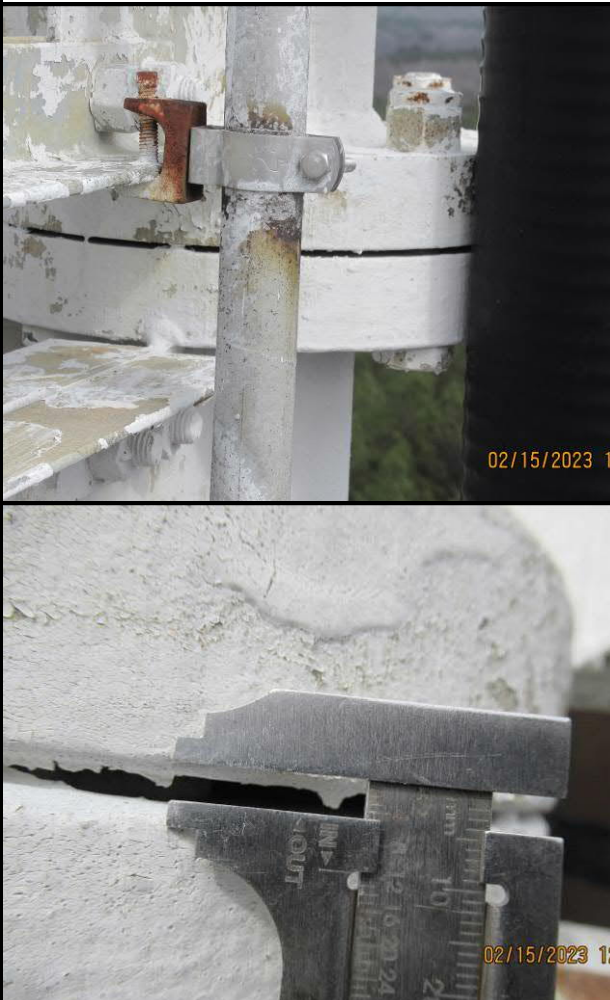
<p><b><u>A.2. Loose members</u></b></p> <p><b>Observation:</b> Gaps ranging in size from 1/8" to 1/4" were observed between the flanges throughout the tower.</p> <p><b>Recommendation:</b> Monitor the flange gaps during the next inspection cycle. If the conditions worsen and the gaps exceed 1/4" are observed, consult with a structural engineer licensed in the state of Mississippi to determine the appropriate course of action.</p>

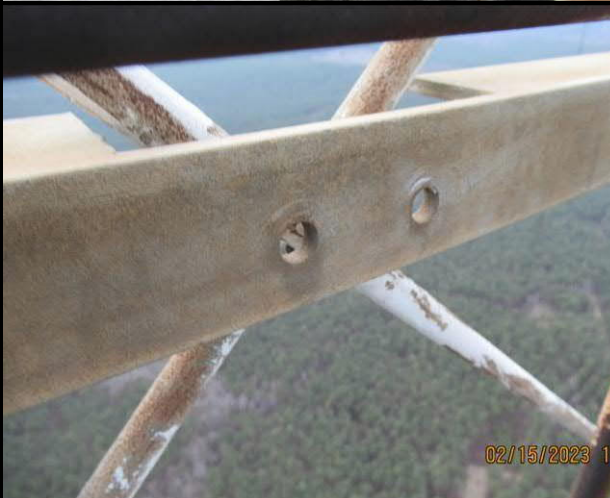
<p><b><u>A.3. Missing members</u></b></p> <p><b>Observation:</b> Modification is missing center U-bolt at 1158-ft on all faces.</p> <p><b>Recommendation:</b> Install center U-bolts or remove the members if they are determined by structural analysis to be no longer required.</p>

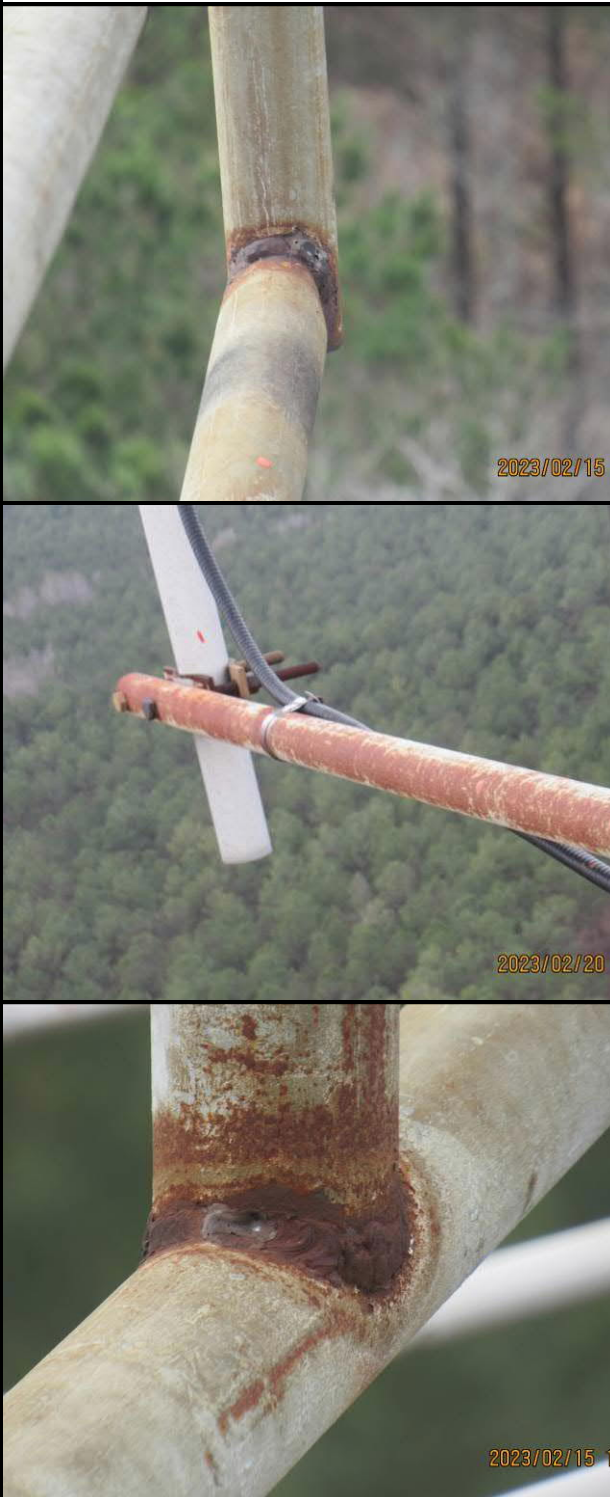
<p><b><u>B. 2. Rust and/or corrosion condition including mounts and accessories</u></b></p> <p><b>Observation:</b> Mild to moderate corrosion was observed in the following locations:</p> <ul style="list-style-type: none"> <li>• 34-ft, 186-ft, 384-ft, 442-ft, and 605-ft on mount on A leg.</li> <li>• 625-ft and 643-ft on mounts on AB face.</li> <li>• 176-ft, 349-ft, 392-ft, and 542-ft on mount on B leg.</li> <li>• 214-ft on mount on BC face.</li> <li>• 60-ft, 95-ft, 138-ft, 146.5-ft, 184-ft, 190-ft, 357-ft, and 515-ft on mount on C leg.</li> <li>• 515-ft on antenna and 1040-ft on mount hardware on C leg.</li> <li>• 1250-ft to 1296-ft on mast antenna</li> <li>• 1298-ft on lighting beacon mount.</li> </ul> <p><b>Recommendation:</b> Notify the equipment owner. All areas of corrosion should be thoroughly cleaned and treated with two coats of a brush on cold galvanizing compound containing at least 95% zinc. If during this process any section loss is observed, the appurtenance or hardware should be replaced with one of equal size and grade.</p>

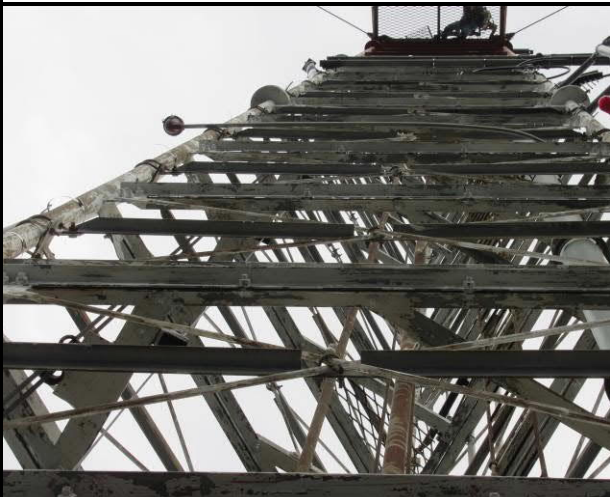
<p><b><u>B.3. FAA or ICAO color marking conditions</u></b></p> <p><b>Observation:</b> The FAA paint is thin and weathered throughout the tower.</p> <p><b>Recommendation:</b> Confirm tower marking requirements per FAA Advisory Circular AC70/7460-1M “Obstruction Marking and Lighting” and install appropriate tower lighting system. If tower marking is required, the structure and feedlines shall be re-painted to meet FAA requirements.</p>

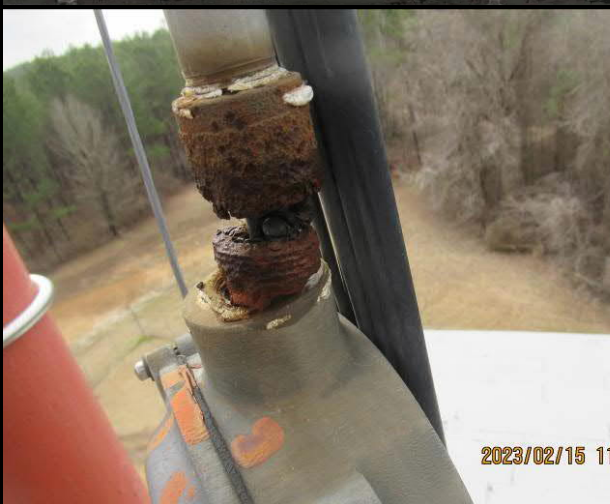
<p><b><u>C.1. Conduit, junction boxes, and fasteners (weather tight and secure)</u></b></p> <p><b>Observation:</b> Broken lighting conduit observed throughout tower on CA face.</p> <p><b>Recommendation:</b> Repair or remove damaged lighting conduit as part of lighting system upgrade.</p>

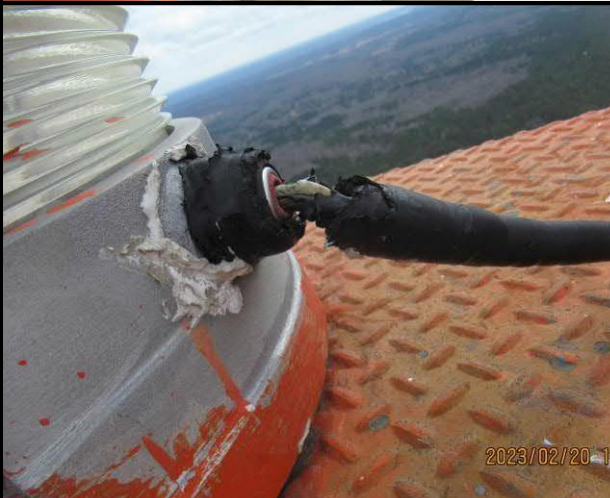
<p><b><u>C.1. Conduit, junction boxes, and fasteners (weather tight and secure)</u></b></p> <p><b>Observation:</b> Damaged coax for side beacon at 579-ft, and top beacon at 1300-ft.</p> <p><b>Recommendation:</b> Repair or remove damaged coax as part of lighting system upgrade.</p>

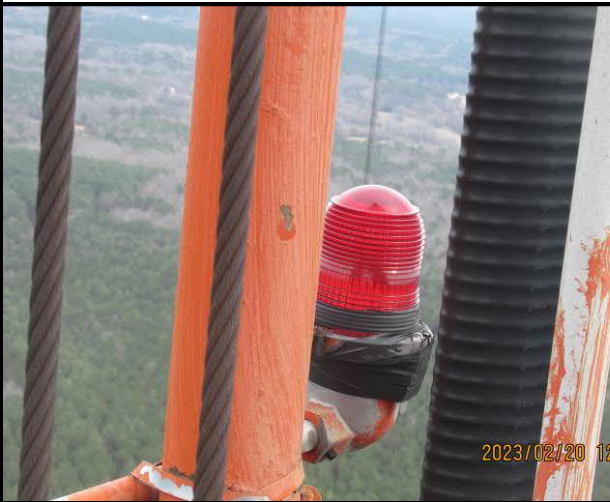
<p><b><u>C.4. Light lenses</u></b></p> <p><b>Observation:</b> Side marker is missing clip at 724-ft on B leg. Side marker cap is secured.</p> <p><b>Recommendation:</b> Repair or replace side marker as part of lighting system upgrade.</p>

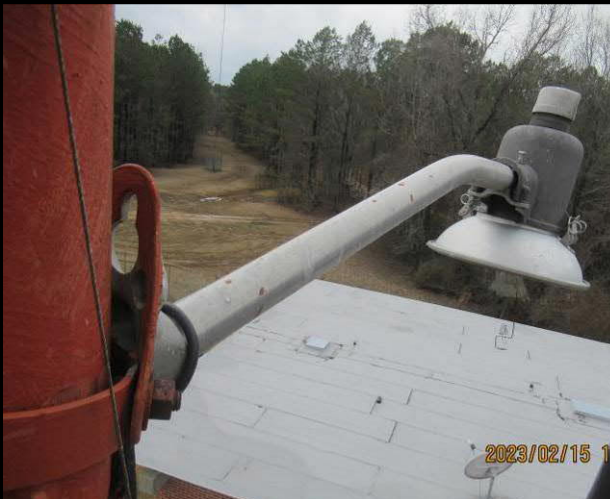
<p><b><u>C.5. Bulb condition</u></b></p> <p><b>Observation:</b> Broken compound lighting lightbulb observed at 39-ft on C leg. (Not part of tower lighting system).</p> <p><b>Recommendation:</b> If required by tower owner, replace broken lighting bulb or remove compound light from tower.</p>

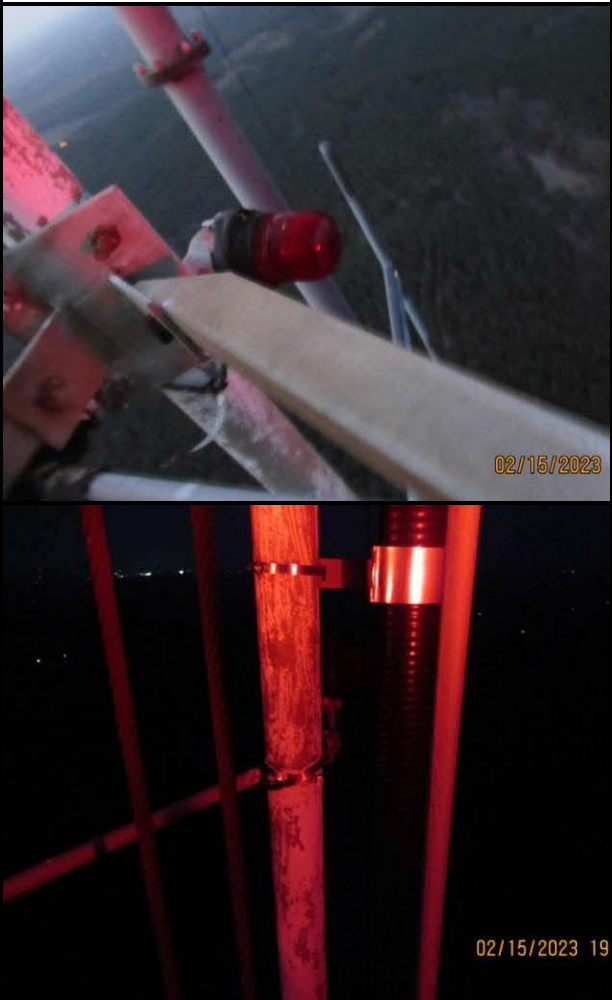
<p><b><u>C.5. Bulb condition</u></b></p> <p><b>Observation:</b> Side markers are out at 1015-ft on B leg and 1160-ft on A and C legs.</p> <p><b>Recommendation:</b> Repair or replace side markers as part of lighting system upgrade.</p>

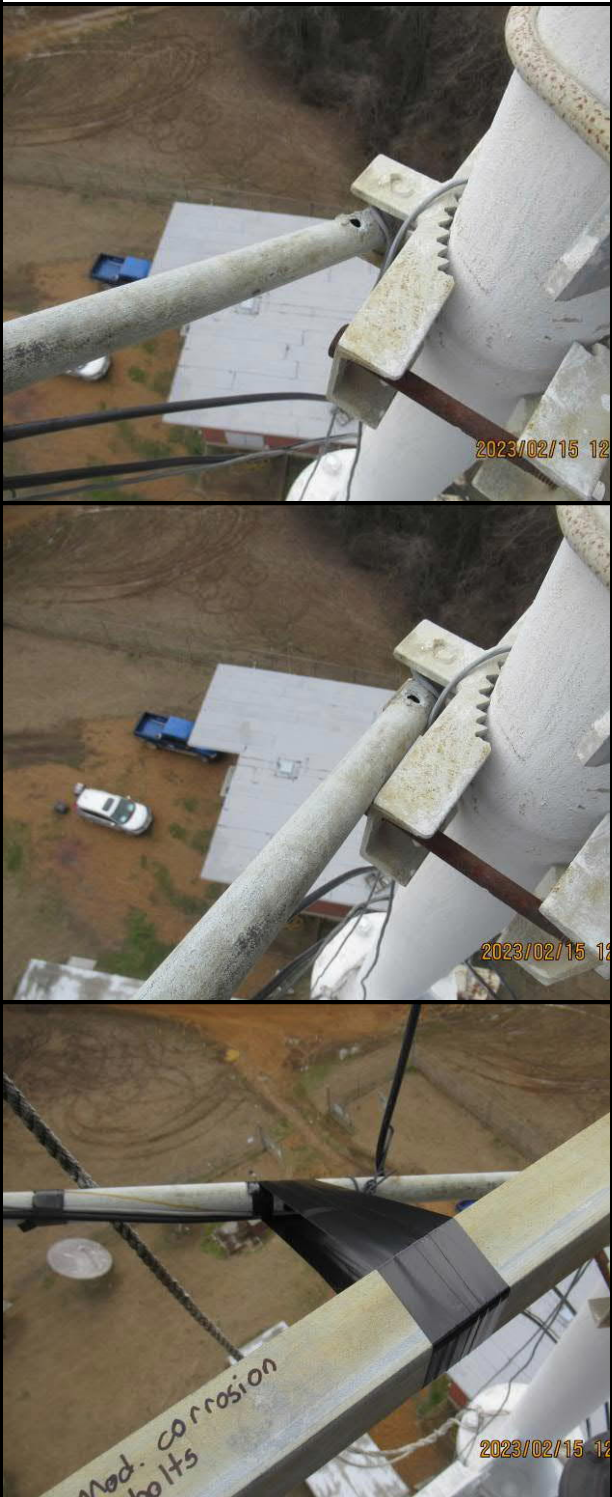
<p><b><u>E.1.d. Antenna and Mounts (Loose or missing hardware)</u></b></p> <p><b>Observation:</b> Mount at 95-ft on C leg was observed to swing freely. Temporarily secured on site.</p> <p><b>Recommendation:</b> Secure mount per manufacturer's specifications, or remove abandoned mount from tower.</p>

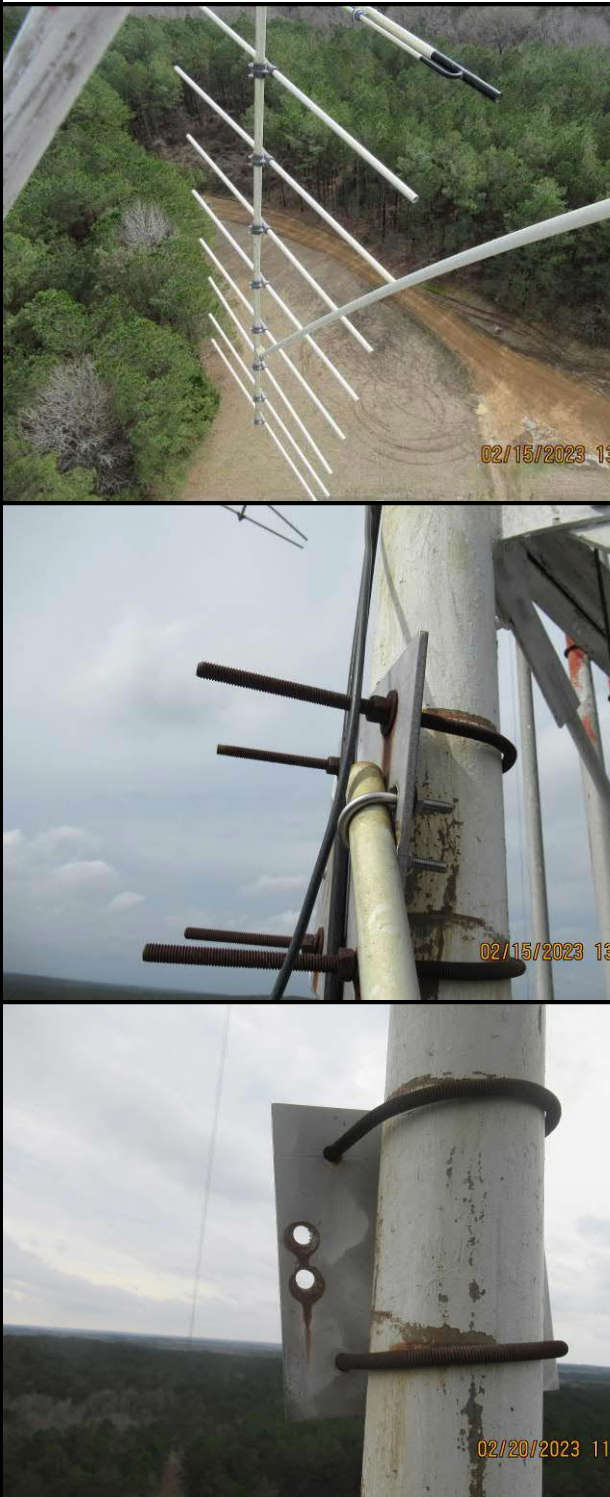
<p><b><u>E.1.d. Antenna and Mounts (Loose or missing hardware)</u></b></p> <p><b>Observation:</b> Unsecured yagi antennas at 171-ft on A and C legs. During the February 20, 2023 visit, TEP removed the unsecured antennas.</p> <p><b>Recommendation:</b> No further action required.</p>

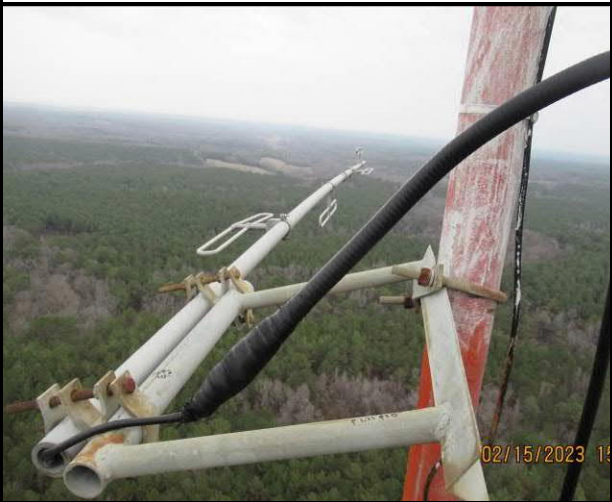
<p><b><u>E.1.d. Antenna and Mounts (Loose or missing hardware)</u></b></p> <p><b>Observation:</b> Improperly mounted dipole at 430-ft on A leg.</p> <p><b>Recommendation:</b> Secure or replace mount per mount manufacturer recommendations. If unused, remove equipment, mount, and coax from the tower.</p>

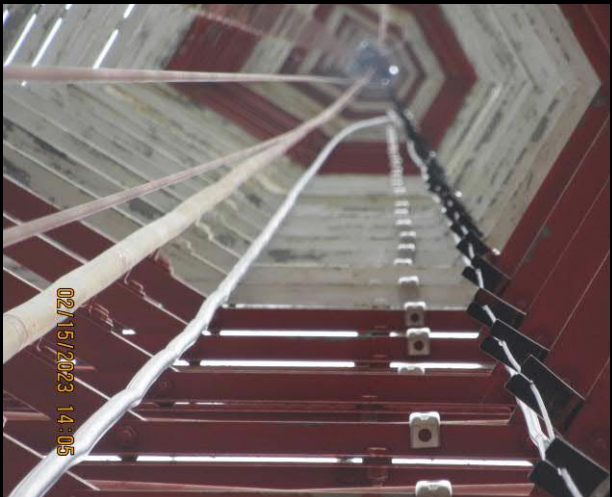
<p><b><u>E.2.b. Feed Lines (Properly secured/supported on the structure and mount)</u></b></p> <p><b>Observation:</b> FH 7/8 coax inside AB face not secured back to structure from 170-ft to 500-ft.</p> <p><b>Recommendation:</b> Secure coax to the tower using appropriate hardware.</p>

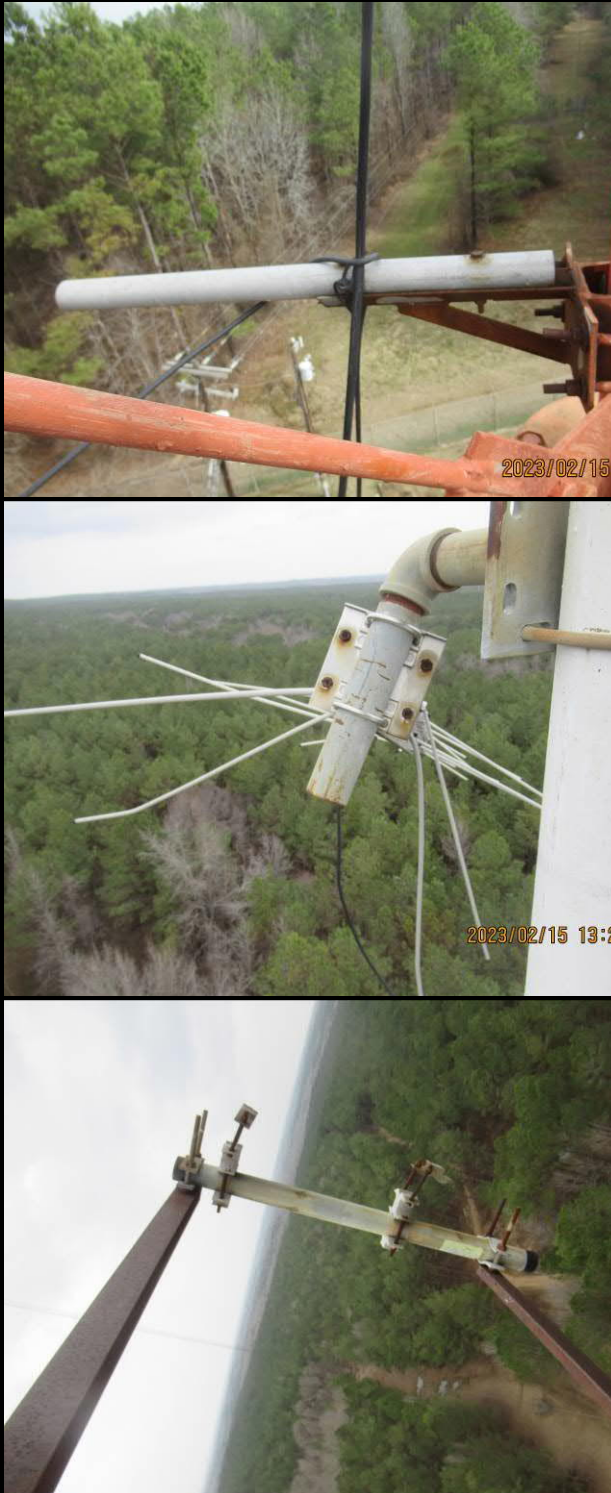
<p><b><u>F.1. Other Appurtenances (Condition)</u></b></p> <p><b>Observation:</b> Abandoned mounts and equipment observed at the following locations:</p> <ul style="list-style-type: none"> <li>• 60-ft on B leg</li> <li>• 95-ft on C leg</li> <li>• 158-ft on AB face</li> <li>• 159-ft on A leg</li> <li>• 171-ft on C leg</li> <li>• 214-ft on BC face</li> <li>• 625-ft on AB face</li> <li>• 643-ft on AB face</li> <li>• 1040-ft on C leg</li> <li>• 1045-ft on AB face</li> </ul> <p><b>Recommendation:</b> Confirm there is no planned future use with tower owner and remove abandoned equipment, mounts, and coax.</p>

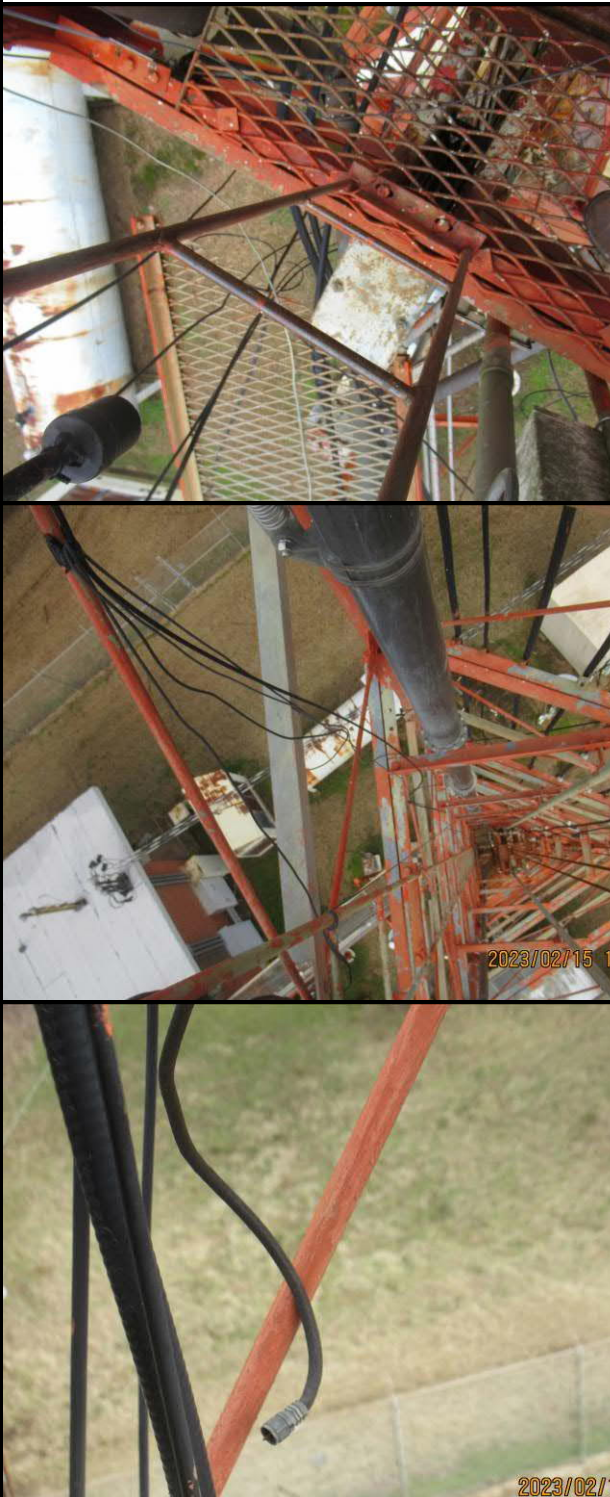
<p><b><u>F.1. Other Appurtenances (Condition)</u></b></p> <p><b>Observation:</b> Abandoned and loose coax observed at the following locations:</p> <ul style="list-style-type: none"> <li>• (1) 1/4" coax from 0-ft to 40-ft</li> <li>• (3) 1/8", (5) 1/4", (1) 5/16", and (1) 3/8" coax from 0-ft to 60-ft</li> <li>• (1) 1/8" coax from 0-ft to 90-ft</li> <li>• (2) 1/4" coax from 0-ft to 169-ft</li> <li>• (1) 3/8" coax from 0-ft to 183-ft</li> <li>• (1) 3/8" coax from 0-ft to 197-ft</li> </ul> <p><b>Recommendation:</b> Confirm there is no planned future use with tower owner and remove abandoned coax.</p>

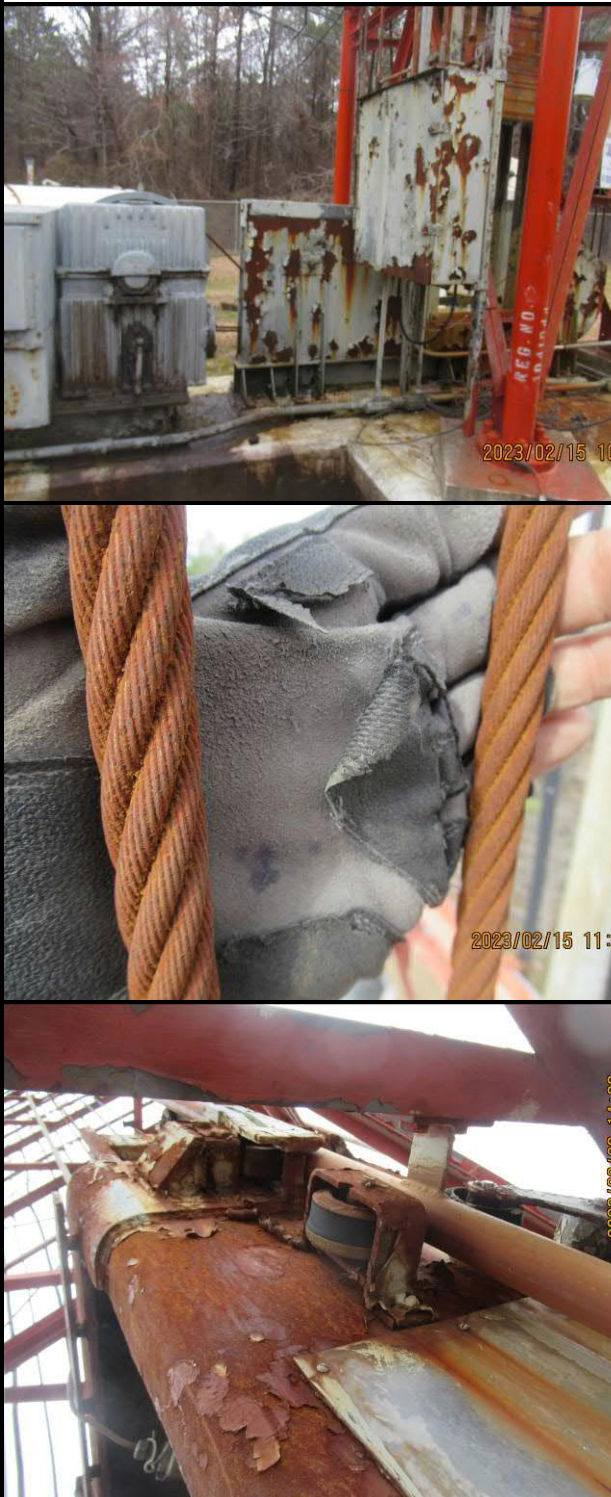
<p><b><u>F.1. Other Appurtenances (Condition)</u></b></p> <p><b>Observation:</b> Severe corrosion and damage to elevator equipment including cables, shafts, box, and machinery at top and bottom.</p> <p><b>Recommendation:</b> Remove elevator and all related hardware and equipment.</p>

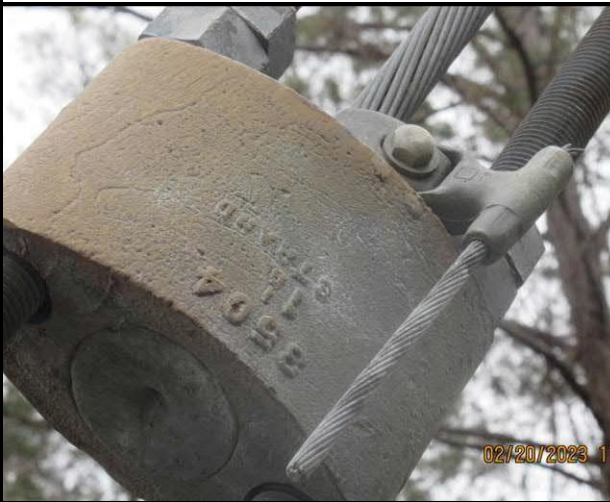
<p><b><u>H.1. Guy strand condition (corrosion, breaks, nicks, kinks, etc.)</u></b></p> <p><b>Observation:</b> Damaged dampener on guy 7 at anchor AA.</p> <p><b>Recommendation:</b> Replace dampener and install per manufacturer's requirements.</p>

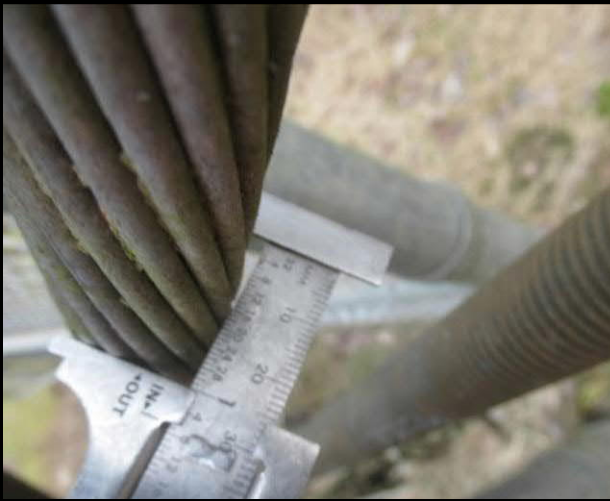
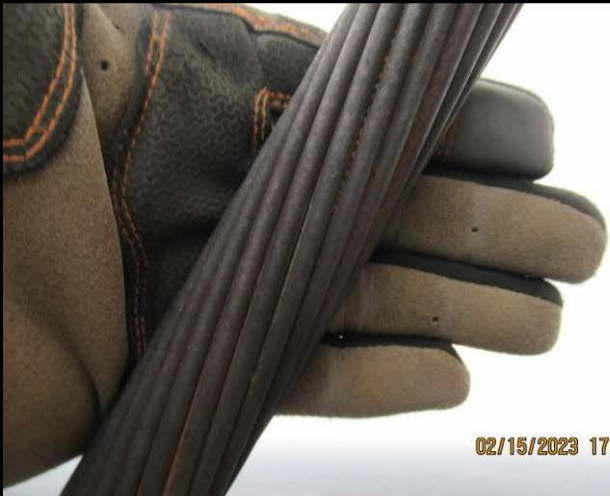
<p><b><u>H.1. Guy strand condition (corrosion, breaks, nicks, kinks, etc.)</u></b></p> <p><b>Observation:</b> Mild to moderate corrosion was observed at all guy wires coming from the tower.</p> <p><b>Recommendation:</b> Monitor the guy wire condition during the next inspection cycle. If cross sectional area loss is observed, replace the guy wire.</p>

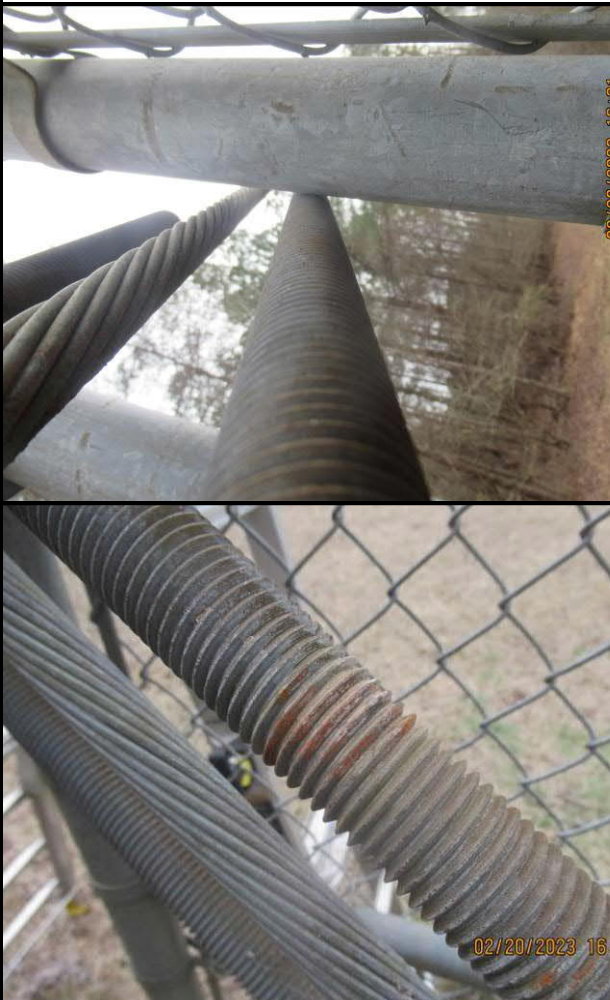
<p><b><u>H.2.a.iii. Guy Hardware Conditions (Turnbuckles or equivalent (cracks, defects, damage, etc.))</u></b></p> <p><b>Observation:</b> Vari grip is in contact with fence at anchor B (guy 1). Surface corrosion was observed on the Vari grip at anchor AA and BB on guy 4 and the nuts for the Vari grips at all anchors.</p> <p><b>Recommendation:</b> Thoroughly clean all areas of corrosion and apply two coats of a cold galvanizing compound containing at least 95% zinc. Monitor point of contact with fence post for material loss during the next inspection cycle. If material loss or excessive corrosion are observed, the fence post should be relocated.</p>

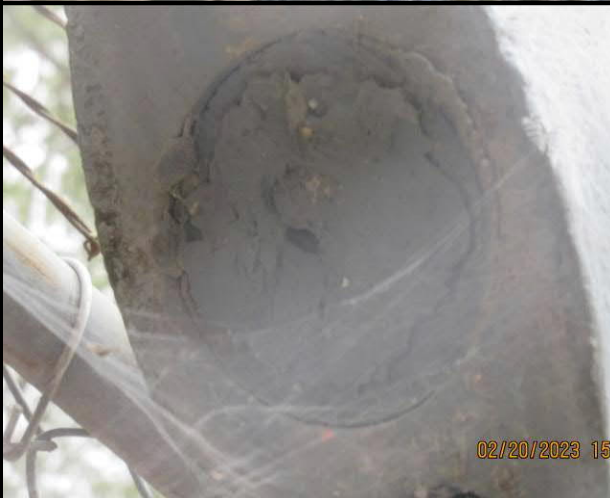
<p><b><u>H.2.d.v. Guy Hardware Conditions (Cable connectors (Poured sockets secure and showing no separation or twisting))</u></b></p> <p><b>Observation:</b> Slight material loss in epoxy at anchor CC (guy 6).</p> <p><b>Recommendation:</b> Monitor the epoxy condition during the next inspection cycle. If significant material loss is observed, repair or replace per the manufacturer's specifications.</p>

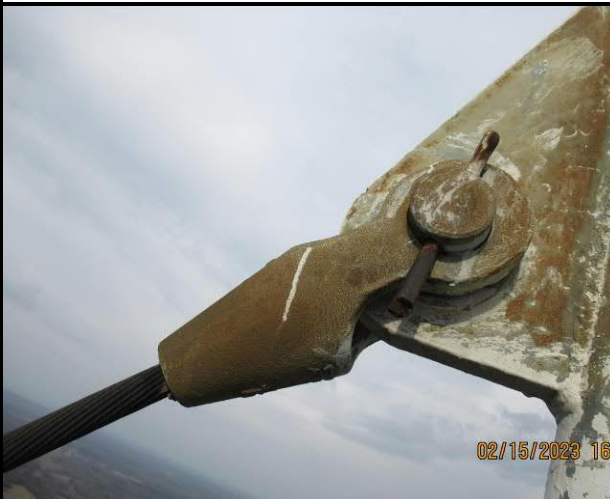
<p><b><u>H.2.d.vi. Guy Hardware Conditions (Cable connectors (Shackles, bolts, pins, and cotter pins))</u></b></p> <p><b>Observation:</b> Corroded cotter pins at all guy anchors and elevated guy levels.</p> <p><b>Recommendation:</b> Replace the cotter pins.</p>

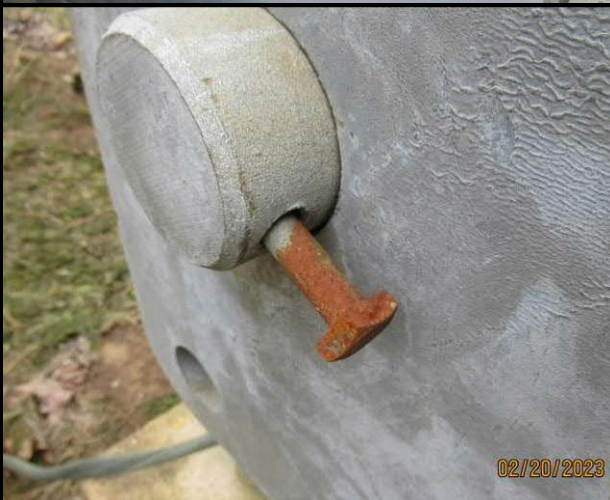
<p><b><u>H.2.d.vi. Guy Hardware Conditions (Cable connectors (Shackles, bolts, pins, and cotter pins))</u></b></p> <p><b>Observation:</b> Corrosion was observed on the fanplate pin's locking pin at all anchors.</p> <p><b>Recommendation:</b> Thoroughly clean all areas of corrosion and apply two coats of a cold galvanizing compound containing at least 95% zinc.</p>

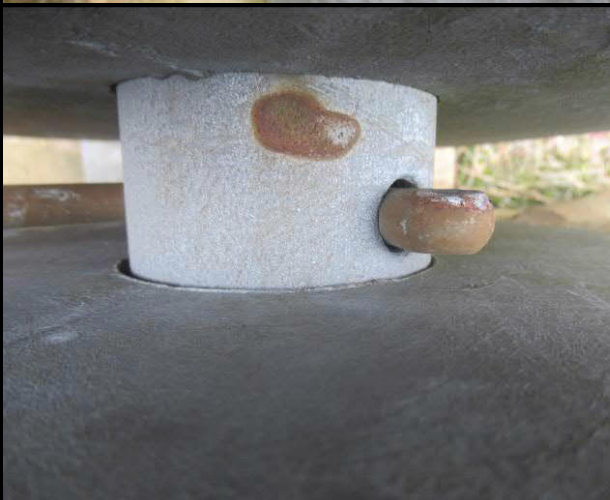
<p><b><u>H.2.d.vi. Guy Hardware Conditions (Cable connectors (Shackles, bolts, pins, and cotter pins))</u></b></p> <p><b>Observation:</b> Surface corrosion was observed on the fanplate's pin at anchor A</p> <p><b>Recommendation:</b> Thoroughly clean all areas of corrosion and apply two coats of a cold galvanizing compound containing at least 95% zinc.</p>

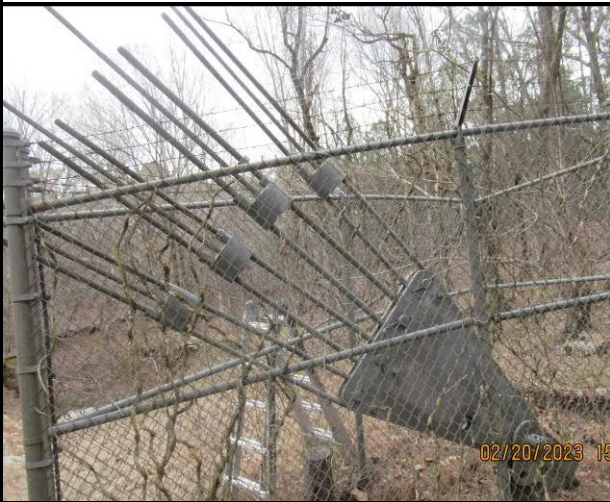
<p><b><u>H.3.a Measure guy tensions</u></b></p> <p><b>Observation:</b> Guy tensions are not within recommended values. See Appendix B for details.</p> <p><b>Recommendation:</b> Re-tension the guy wires to within recommended limits while ensuring twist and plumb are also within recommended limits.</p>

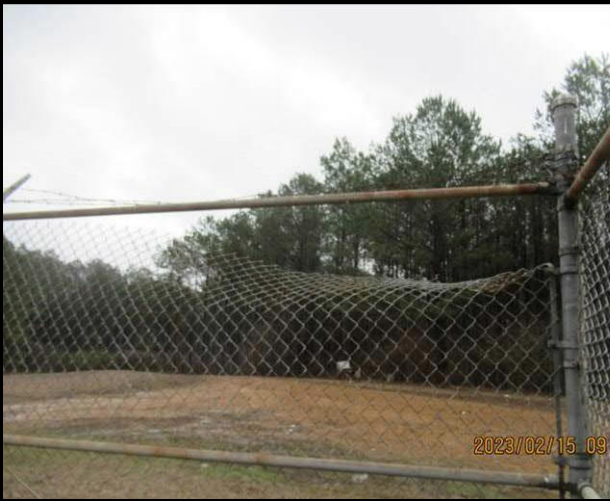
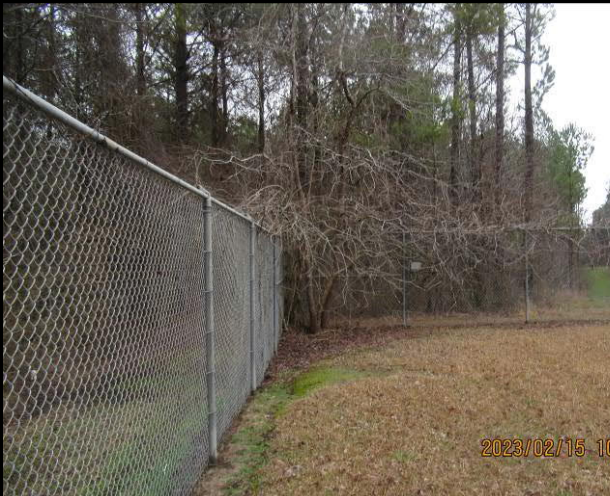
<p><b><u>I.1.c. Ground condition (Site condition (standing water, drainage, trees, etc.))</u></b></p> <p><b>Observation:</b> A hole is present on the southwest side of the compound fence. Limbs are present on the northwest side of the compound fence. Loose barbed wire is present on south side of the compound fence.</p> <p><b>Recommendation:</b> Remove vegetation and repair the fence.</p>

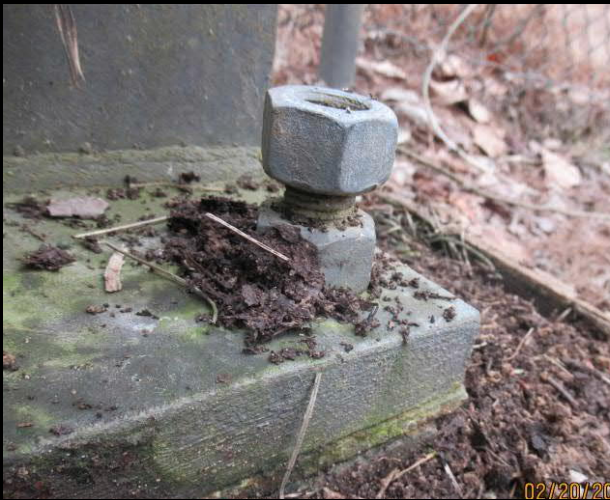
Photographs	Observations and Recommendations
  <p>02/20/23</p>	<p><b><u>I.2.a. Anchorage condition (Top and bottom base plate nuts tight)</u></b></p> <p><b>Observation:</b> 3/16" gap between anchor AA baseplate and grout.</p> <p><b>Recommendation:</b> Monitor gap during the next inspection cycle to determine if any movement has occurred. If the gap is found to be larger than 3/16", removal of grout for further inspection may be required.</p>

<p>02/20/2023</p>   <p>02/20/2023</p>	<p><b><u>I.2.b. Anchorage condition (Nut locking device)</u></b></p> <p><b>Observation:</b> Loose nut-locking device at anchor CC on anchor rod bolt. Missing nut-locking devices (2) on anchor rod bolts at anchor CC.</p> <p><b>Recommendation:</b> Install and tighten all anchor rod nuts per Section 4.9.9 of ANSI/TIA-222-H.</p>

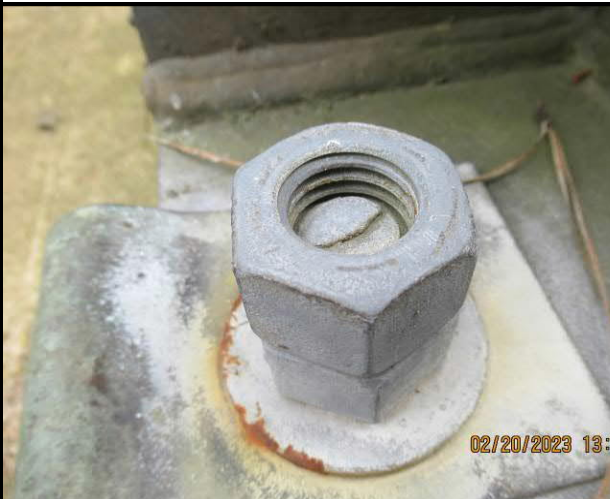
<p><b><u>I.2.b. Anchorage condition (Nut locking device)</u></b></p> <p><b>Observation:</b> Locking nuts for anchor rods are recessed at all guy anchors.</p> <p><b>Recommendation:</b> Remove the top nuts to prevent water collection and corrosion on the anchor rods. Install monitor lines on the anchor nuts and monitor annually to ensure the nuts are not backing off the anchorages.</p>

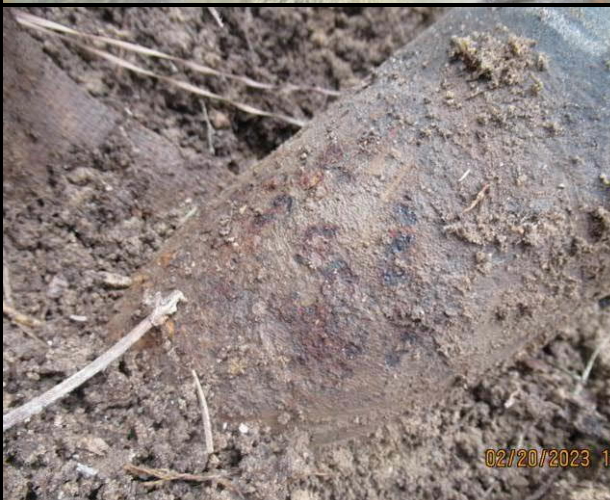
<p><b><u>I.3. Guy Mast Anchors (Anchor shaft condition below grade)</u></b></p> <p><b>Observation:</b> Moderate corrosion was observed on the anchor rod shaft at anchor CC.</p> <p><b>Recommendation:</b> Thoroughly clean all areas of corrosion and apply two coats of a cold galvanizing compound containing at least 95% zinc.</p>

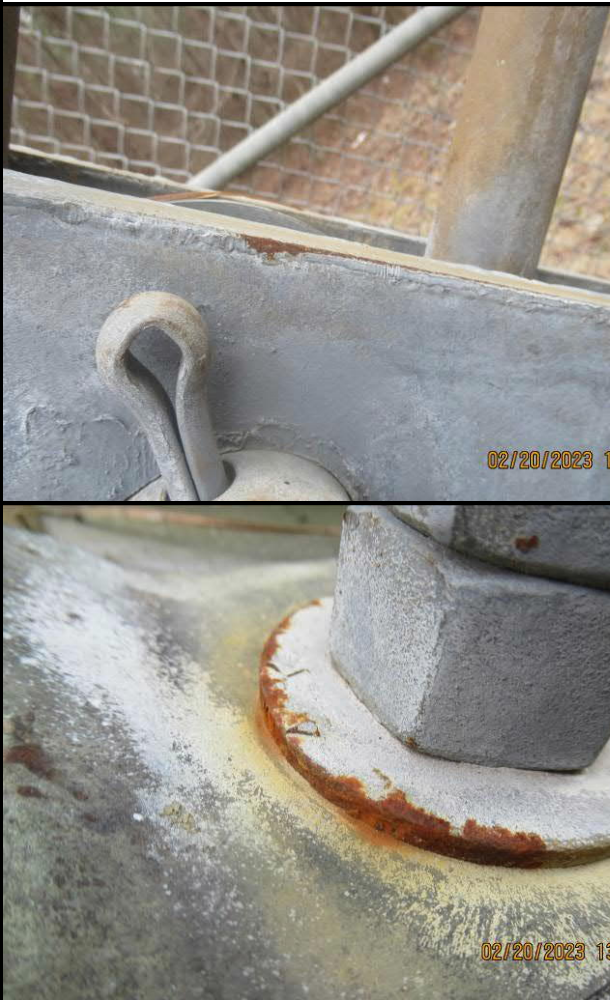
<p><b><u>J.4. Guy Mast Anchors (Corrosion control measures (galvanizing, coating, concrete encasement, cathodic protection systems, etc.))</u></b></p> <p><b>Observation:</b> Surface corrosion was observed on the fanplate at anchors BB, A, and AA. Surface corrosion was observed on the washer for grounding at anchor A and C.</p> <p><b>Recommendation:</b> Thoroughly clean all areas of corrosion and apply two coats of a cold galvanizing compound containing at least 95% zinc.</p>
