Tower Engineering Professionals, Inc.
326 Tryon Road
Raleigh, NC 27603
(919) 661-6351
bhm_inspections@tepgroup.net

Subject: Maintenance and Condition Assessment Report

FCC Designation	ASR Number:	1041037
Client Designation:	Client Site Name:	WMAW
Inspection Firm Designation:	TEP Project Number:	327679.814192
Site Data:	2315 County Road 20	
	Louin, Jasper County, MS 39338	
	Latitude N 32° 8' 19.0", Longitude W 89° 5' 35.9"	
	997 Foot – Guyed Tower

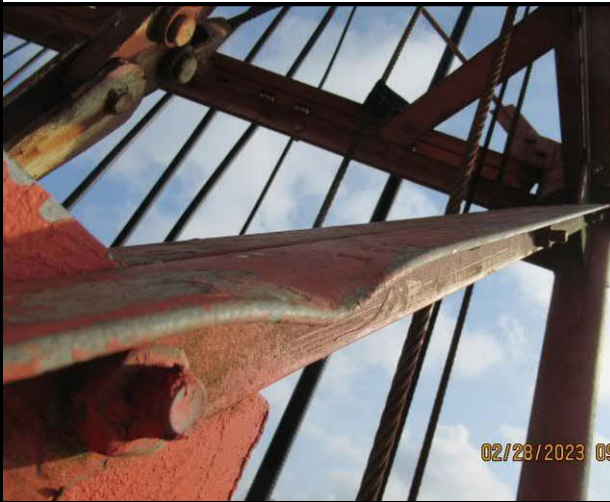
<p><u>A.1. Damaged members (legs and bracing)</u></p> <p>Observation: A bent L2x2x3/16" diagonal member was observed at 26-ft, and 995' on the BC Face. Maximum deflections of 5/8" and 1", respectively, were recorded.</p> <p>Recommendation: Repair or replace the damaged diagonals.</p>

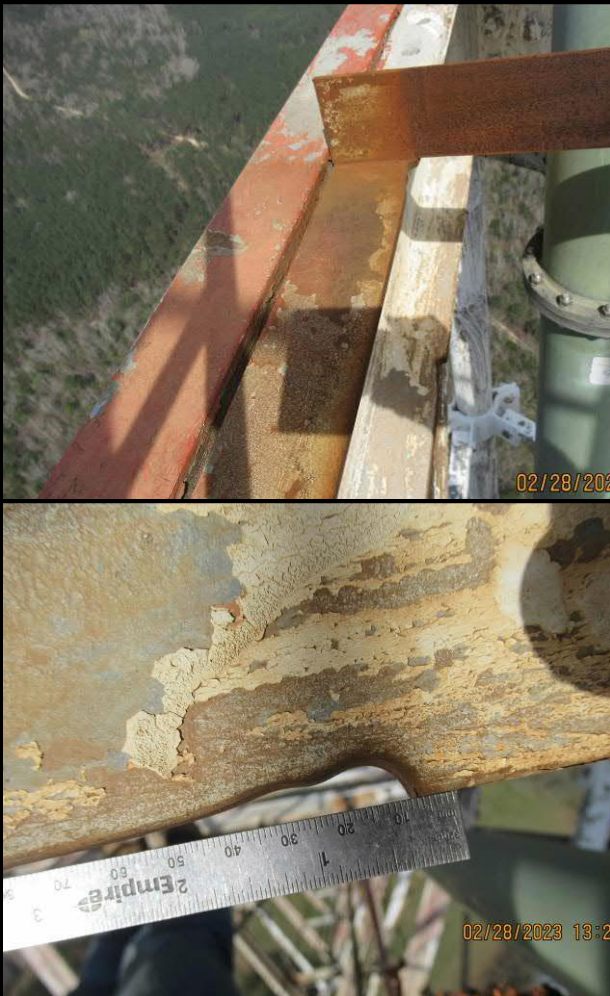
<p><u>A.1. Damaged members (legs and bracing)</u></p> <p>Observation: Material loss and surface corrosion was observed inside C channel at guy level 3, due to contact with elevator cables.</p> <p>Recommendation: A structural engineer licensed in the state of Mississippi should review any areas of section loss to determine the appropriate course of action. Thoroughly clean all areas of corrosion and apply two coats of a cold galvanizing compound containing at least 95% zinc.</p>

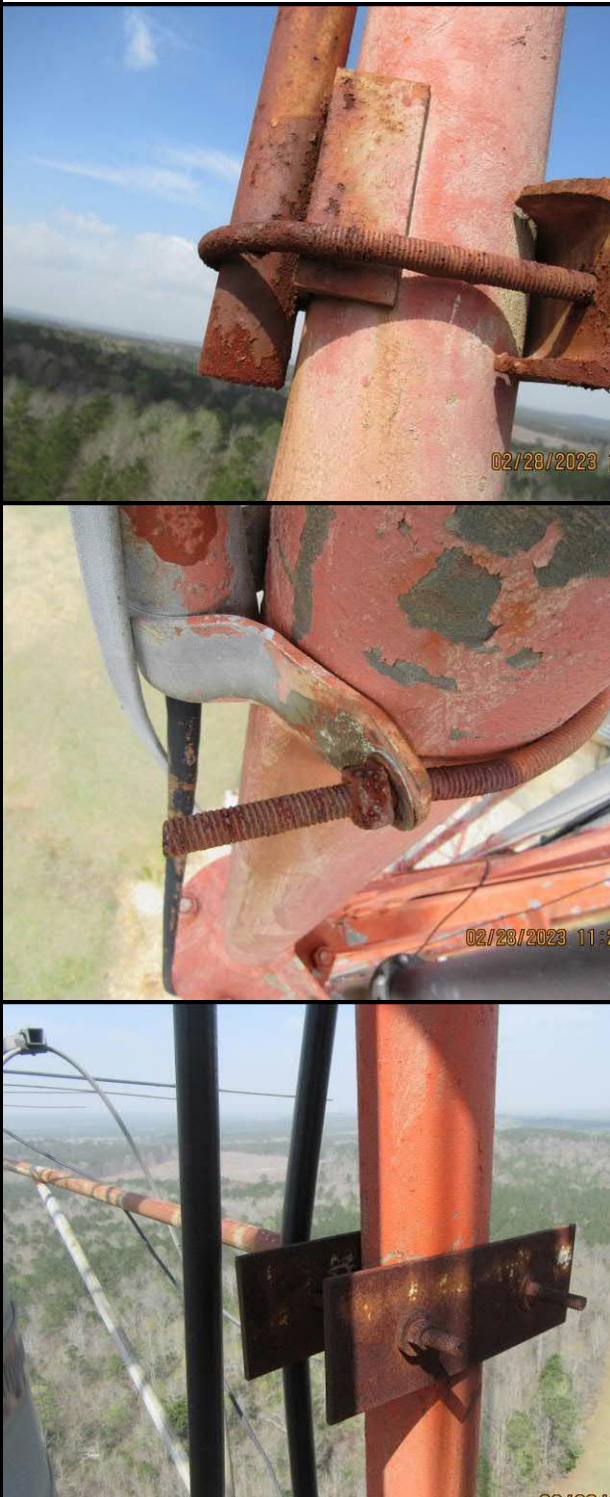
<p><u>B.2. Rust and/or corrosion condition including mounts and accessories</u></p> <p>Observation: Moderate to severe corrosion was observed in the following locations:</p> <ul style="list-style-type: none"> • Abandoned mount pipe hardware on C leg at 96-ft. • Light mounting hardware on B leg at 34-ft. • Mount hardware on CA face at 198.5-ft. • Mount hardware on A leg at 215.5-ft. • Mount hardware on BC face at 396-ft and 403-ft. • Mount hardware on BC face at 512-ft and 530-ft. • Mount hardware on B leg at 681-ft, 693-ft, 704-ft, and 712-ft. • Mount hardware on B leg at 747.5-ft. • Mount on C leg at 764-ft. <p>Recommendation: Notify the equipment owner. All areas of corrosion should be thoroughly cleaned and treated with two coats of cold galvanizing compound containing at least 95% zinc. If during this process any section loss is observed, the equipment or hardware should be replaced with one of equal size and grade.</p>

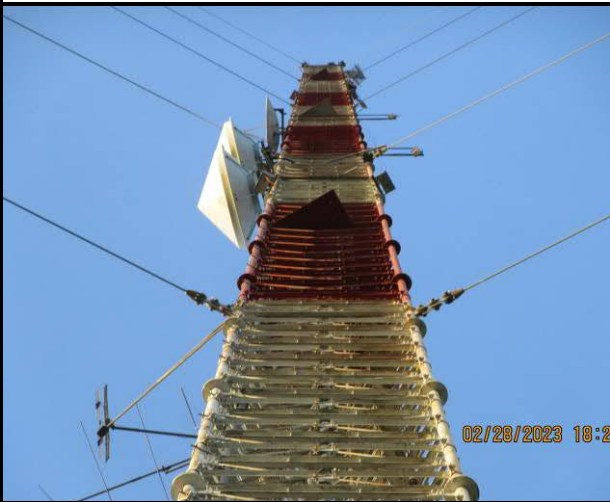
<p><u>B.3. FAA or ICAO color marking Condition</u></p> <p>Observation: The FAA paint is thin and weathered throughout the tower.</p> <p>Recommendation: Confirm owner marking requirements per FAA Advisory Circular AC70/7460-1M "Obstruction Marking and Lighting" and install appropriate tower lighting system. If tower marking is required, the structure and feedlines shall be re-painted to meet FAA requirements.</p>

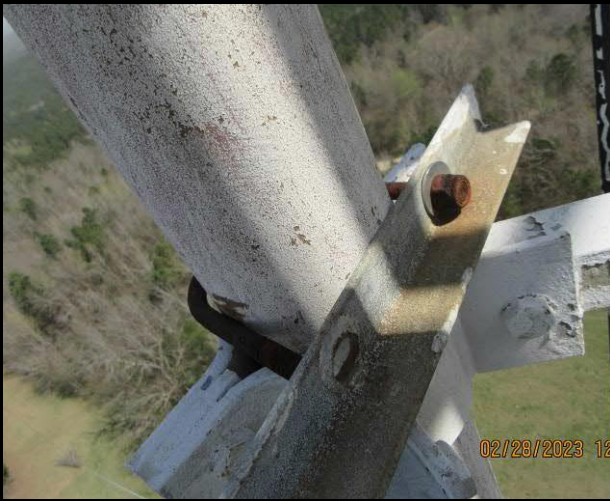
<p><u>E.1.d. Antenna and Mounts (Loose or missing hardware)</u></p> <p>Observation: Antenna mount on CA face at 198.5-ft is missing mount hardware.</p> <p>Recommendation: Secure or replace mount per manufacturer recommendations. If unused or abandoned, remove equipment, mount, and coax from tower.</p>

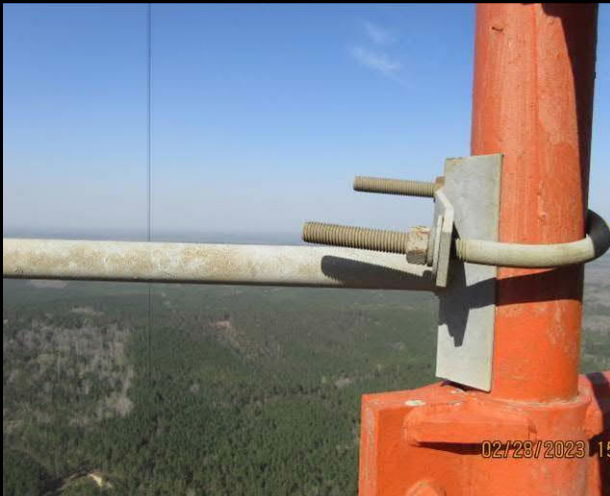
<p><u>E.1.d. Antenna and Mounts (Loose or missing hardware)</u></p> <p>Observation: Skewed u-bolt on dipole at 612-ft and 637-ft on A leg.</p> <p>Recommendation: Secure or replace mount per manufacturer recommendations. If unused or abandoned, remove equipment, mount, and coax from tower.</p>

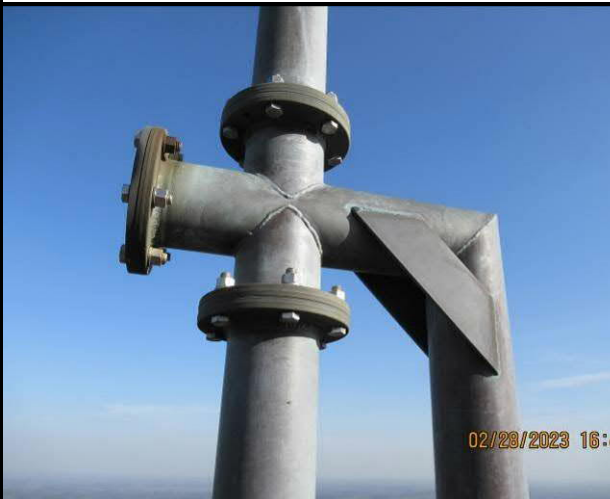
<p><u>E.2.a. Feed Lines (Flanges, seals, dents, jacket damage, grounding, etc.)</u></p> <p>Observation: Gas leaking heard at 876-ft from FM antenna to coax connection. Could not verify precise flange.</p> <p>Recommendation: Consult broadcast operator regarding appropriate course of action.</p>

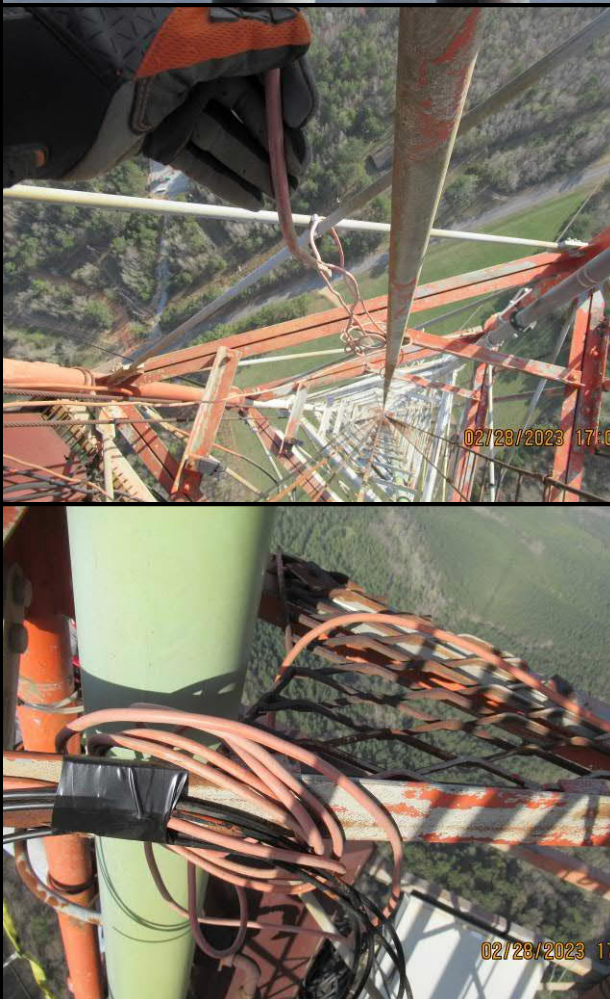
<p><u>E.2.b. Feed Lines (Properly secured/supported on the structure and mount)</u></p> <p>Observation: Unsecured coax at 510-ft, 764-ft, 800-ft. TEP temporarily secured all coax fall hazards.</p> <p>Recommendation: Remove the abandoned coax.</p>

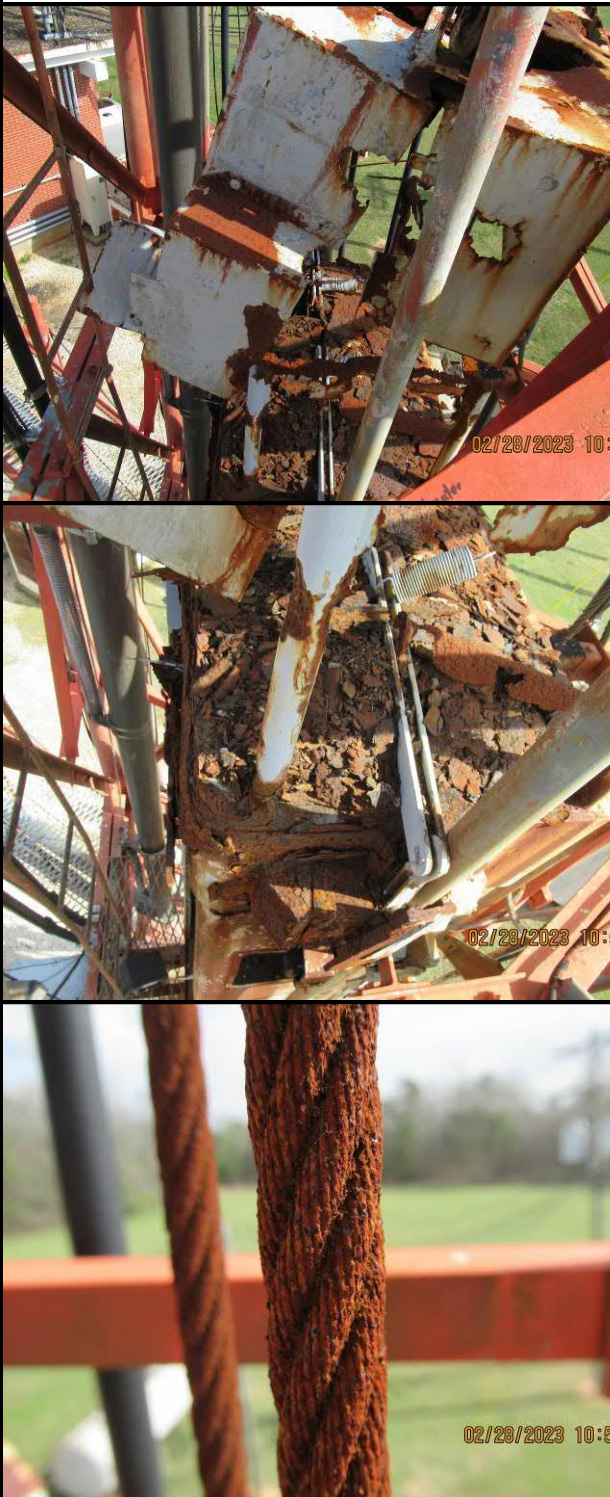
<p><u>F.1. Other Appurtenances (Condition)</u></p> <p>Observation: Severe corrosion and damage to elevator equipment including cables, shafts, box, and machinery at top and bottom.</p> <p>Recommendation: Remove elevator and all related hardware and equipment.</p>

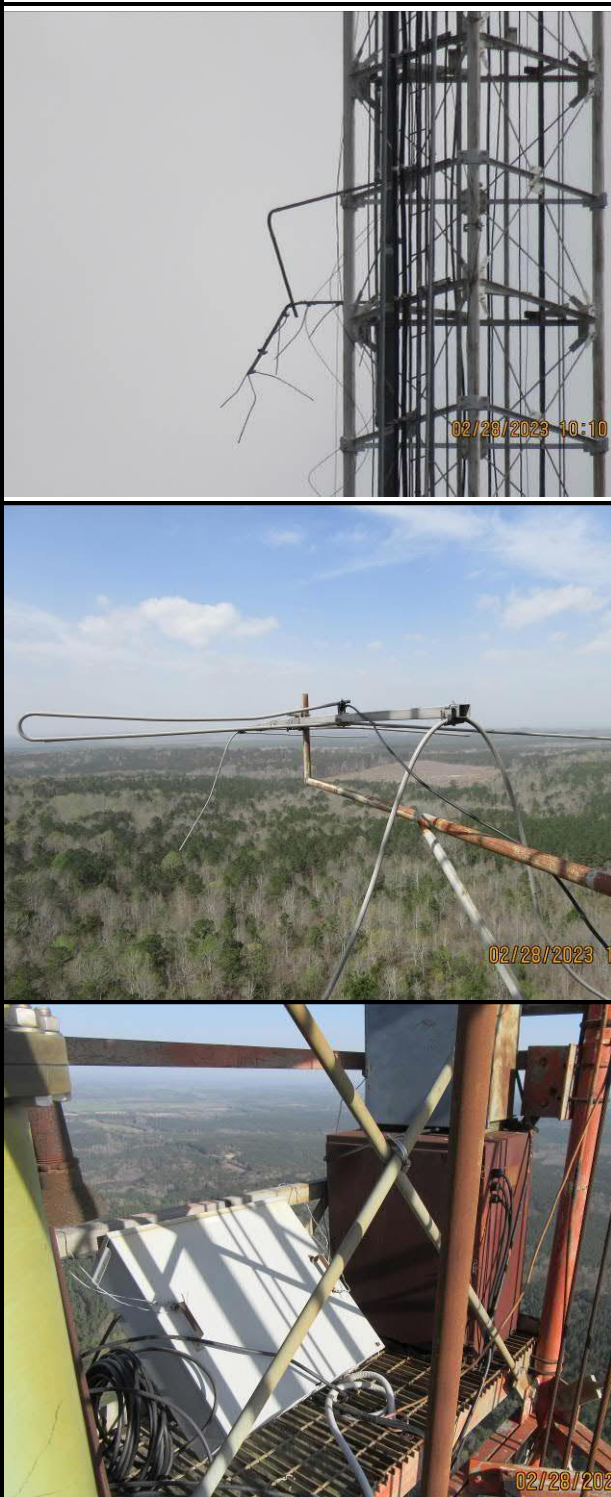
<p><u>F.1. Other Appurtenances (Condition)</u></p> <p>Observation: Abandoned Mounts and equipment observed at the following locations:</p> <ul style="list-style-type: none"> • 96-ft on C leg • 134-ft on A leg • 215.5-ft on A leg • 344-ft on CA face • 466-ft on C leg • 484.5-ft on C leg • 497-ft on C leg • 747.5-ft on B leg • 764-ft on C leg • 768-ft on C leg • 798-ft on AB face <p>Recommendation: Confirm there is no planned future use with tower owner and remove abandoned equipment, mounts, and coax.</p>

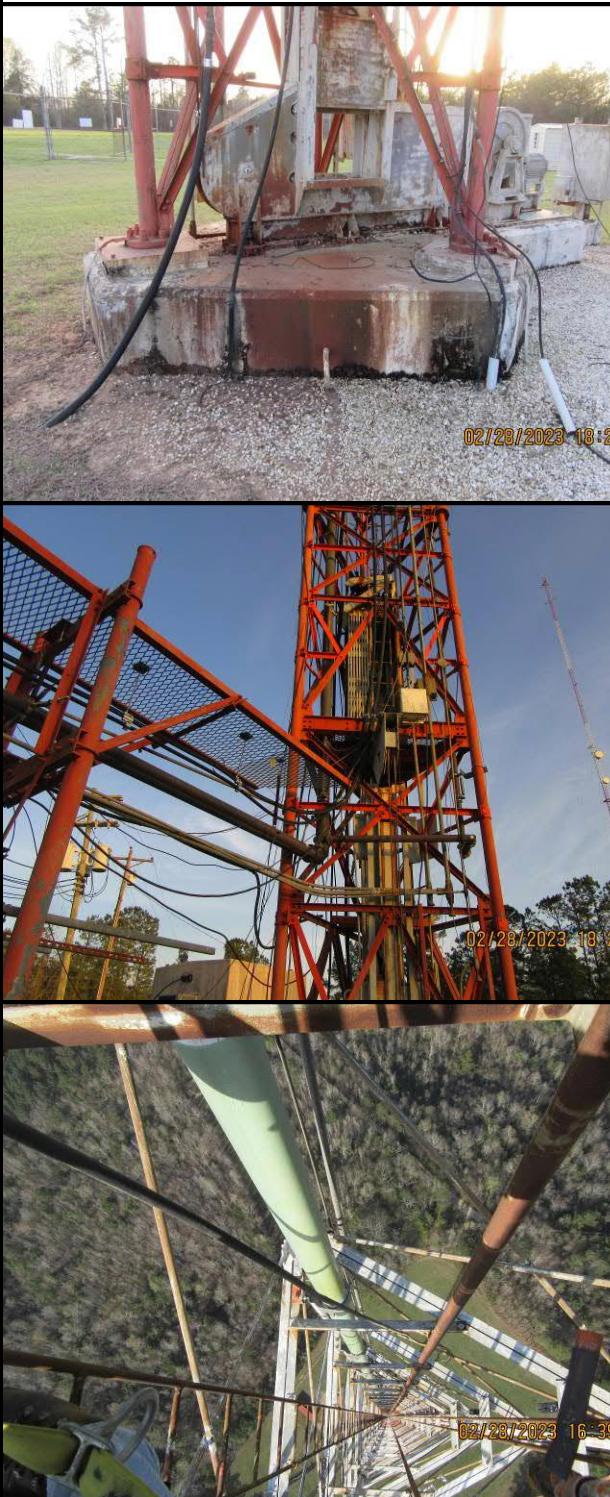
<p><u>F.1. Other Appurtenances (Condition)</u></p> <p>Observation: Abandoned and loose coax observed at the following locations:</p> <ul style="list-style-type: none"> • (1) 1/4" coax from 0-ft to 81-ft • (1) 1/4" coax from 0-ft to 93-ft • (1) 1/8" coax from 0-ft to 120-ft • (1) 1/2" coax from 0-ft to 198-ft • (1) 1/8" coax from 0-ft to 200-ft • (3) 1/4" coax from 0-ft to 267-ft • (1) 1/2" coax from 0-ft to 464-ft • (1) 1/4" coax from 0-ft to 517-ft • (1) 1/4" coax from 0-ft to 758-ft • (1) 5/8" coax from 0-ft to 762-ft • (1) 3/8" coax from 0-ft to 798-ft • (1) 1-1/4" conduit from 0-ft to 800-ft • (2) 3/8" coax from 764-ft to 800-ft <p>Recommendation: Confirm there is no planned future use with tower owner and remove abandoned coax.</p>

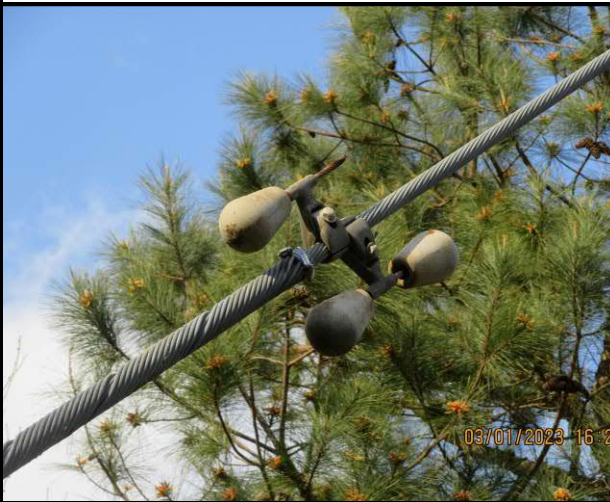
<p><u>H.1. Guy strand condition (Corrosion, breaks, nicks, kinks, etc.)</u></p> <p>Observation: A damaged dampener on guy 5 at anchor CCC.</p> <p>Recommendation: Replace dampener and install per manufacturer's requirements.</p>

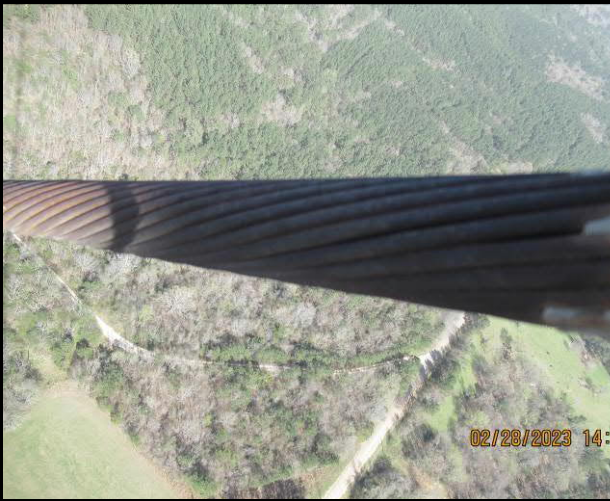
<p><u>H.1. Guy strand condition (Corrosion, breaks, nicks, kinks, etc.)</u></p> <p>Observation: Mild to moderate corrosion was observed on guy level 3 and 4 wires coming from tower.</p> <p>Recommendation: Monitor the guy wire condition during the next inspection cycle. If cross sectional area loss is observed, replace the guy wire.</p>

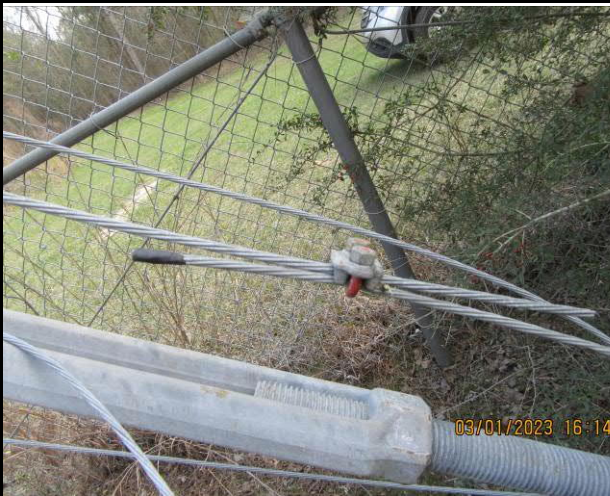
<p><u>H.2.a.ii. Guy Hardware Conditions (Turnbuckles or equivalent (secure and safety properly applied))</u></p> <p>Observation: Turnbuckle safety loop is undersize and is missing a second wire rope clamp at AA, BB, and CC anchor.</p> <p>Recommendation: Install proper sized turnbuckle safety loop with two wire rope clamps.</p>

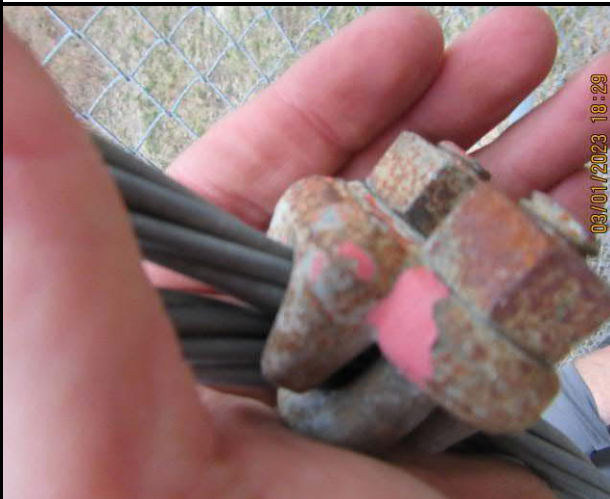
<p><u>H.2.a.ii. Guy Hardware Conditions (Turnbuckles or equivalent (secure and safety properly applied))</u></p> <p>Observation: Corroded wire clamps were observed at AAA, BBB, and CCC anchor.</p> <p>Recommendation: Thoroughly clean all areas of corrosion and apply two coats of a cold galvanizing compound containing at least 95% zinc.</p>

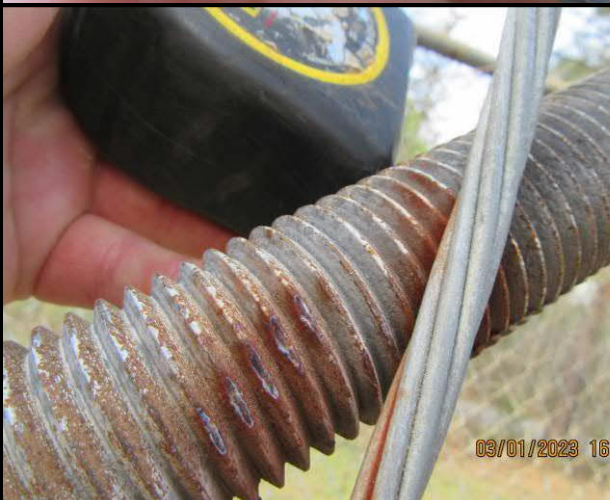
<p><u>H.2.a.iii. Guy hardware Conditions (Turnbuckles or equivalent (cracks, defects, damage, etc.))</u></p> <p>Observation: Damaged threads were observed on Vari grips at anchor A on guy 1, and Anchor BBB guy 4.</p> <p>Recommendation: Monitor Vari grip condition during the next inspection cycle. If condition worsens or interferes with function, replace the Vari grip.</p>

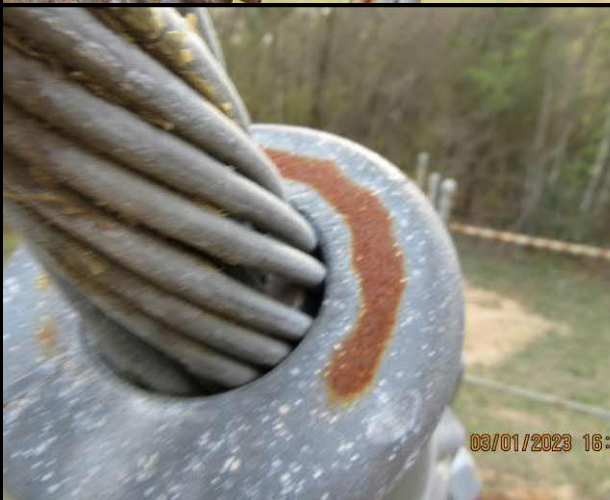
<p><u>H.2.a.iii. Guy hardware Conditions (Turnbuckles or equivalent (cracks, defects, damage, etc.))</u></p> <p>Observation: Surface corrosion was observed on Vari grips, turnbuckles and poured sockets at anchor A, B, and C on guy 1, anchor AA, BB on guy 3, anchor AAA, BBB, and CCC on guy 4, and guy 5.</p> <p>Recommendation: Thoroughly clean all areas of corrosion and apply two coats of a cold galvanizing compound containing at least 95% zinc.</p>

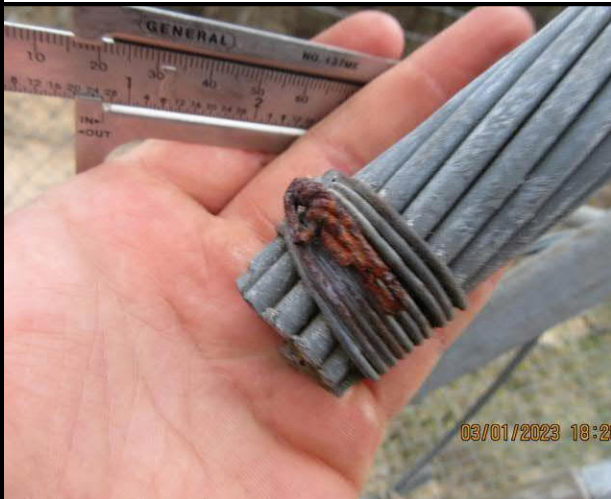
<p><u>H.2.d.ii. Guy Hardware Conditions (Cable connectors (Wire serving))</u></p> <p>Observation: Corroded serving on Guy 5 at AAA anchor, and on guy 3 at CC anchor.</p> <p>Recommendation: Replace with stainless steel serving.</p>

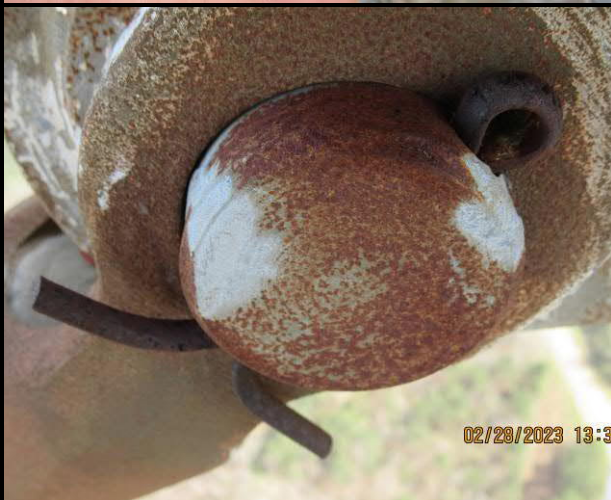
<p><u>H.2.d.vi. Guy Hardware Conditions (Cable connectors (Shackles, bolts, and cotter pins))</u></p> <p>Observation: Corroded cotter pins on elevated guy level 3 and 4 and at anchors AA, AAA, BB, BBB, CC, CCC.</p> <p>Recommendation: Replace cotter pins.</p>

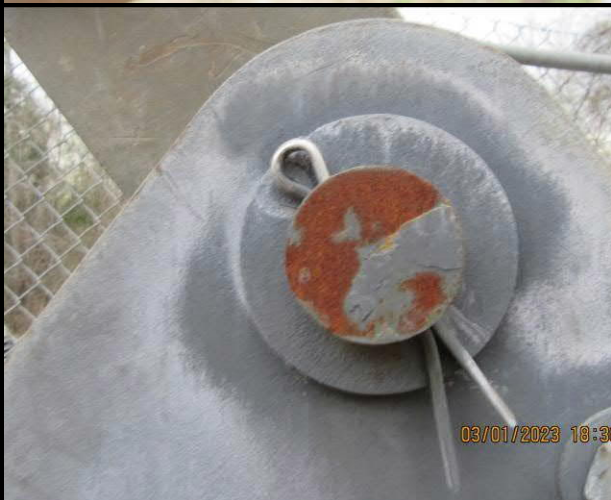
<p><u>H.2.d.vi. Guy Hardware Conditions (Cable connectors (Shackles, bolts, and cotter pins))</u></p> <p>Observation: Surface corrosion was observed on the fan plate's pin at Anchor A on guy 1 and Anchor AAA on guy 5.</p> <p>Recommendation: Thoroughly clean all areas of corrosion and apply two coats of a cold galvanizing compound containing at least 95% zinc.</p>

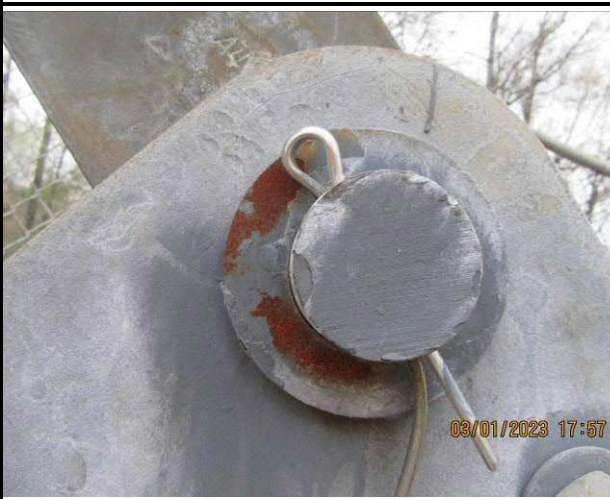
<p><u>H.2.d.vi. Guy Hardware Conditions (Cable connectors (Shackles, bolts, and cotter pins))</u></p> <p>Observation: Corrosion was observed on guy anchor washers at AA, B, BBB anchor.</p> <p>Recommendation: Thoroughly clean all areas of corrosion and apply two coats of a cold galvanizing compound containing at least 95% zinc.</p>

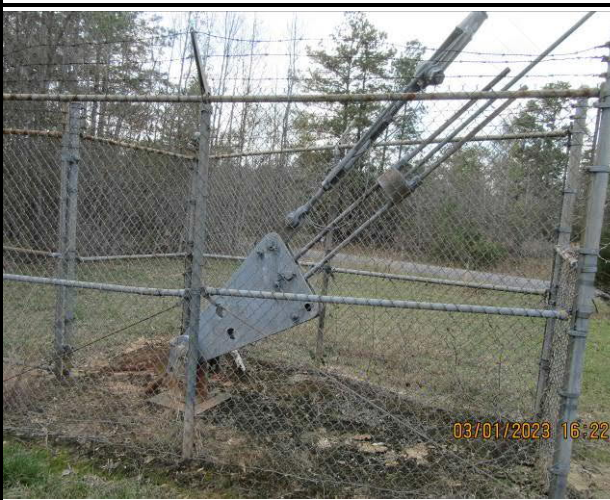
<p><u>H.3.a Measure guy tensions</u></p> <p>Observation: Guy tensions are not within recommended values. See Appendix B for details.</p> <p>Recommendation: Re-tension the guy wires to within recommended limits while ensuring twist and plumb are also within recommended limits.</p>

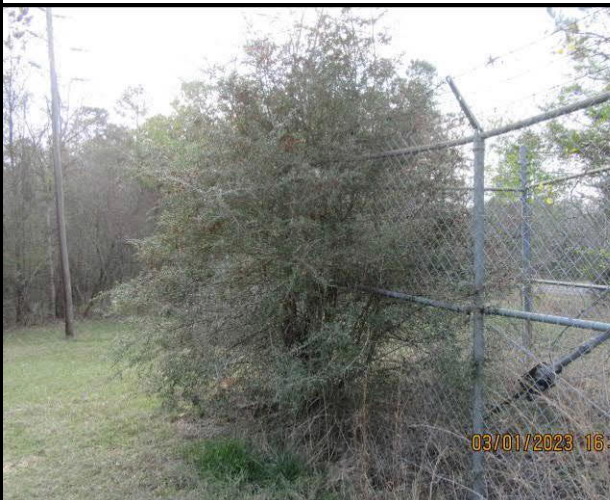
<p><u>I.1.c. Ground condition (Site condition (standing water, drainage, trees, etc.))</u></p> <p>Observation: Trees and other foliage were observed growing in A, AA, and CC anchor compound.</p> <p>Recommendation: Remove the vegetation and spray to prevent future growth.</p>

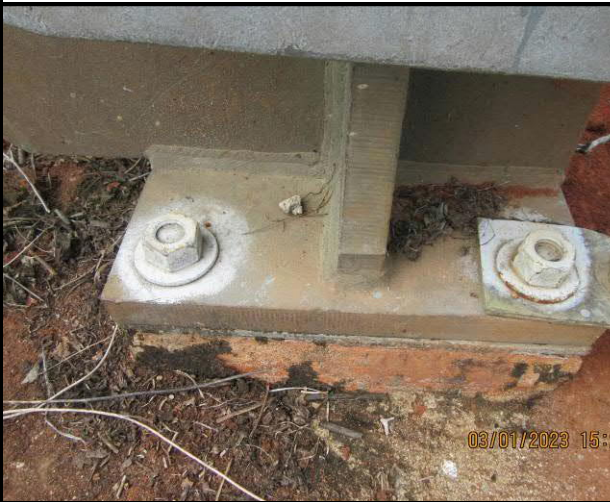
<p><u>I.2.a. Anchorage condition (Top and bottom base plate nuts tight)</u></p> <p>Observation: Locking Nuts for anchor rods are recessed at C guy anchor.</p> <p>Recommendation: A structural engineer licensed in the state of Mississippi should review the acceptability of partially threaded anchor rod nuts and determine the appropriate course of action. Clean and fill recessed area with approved epoxy to prevent standing water and corrosion.</p>

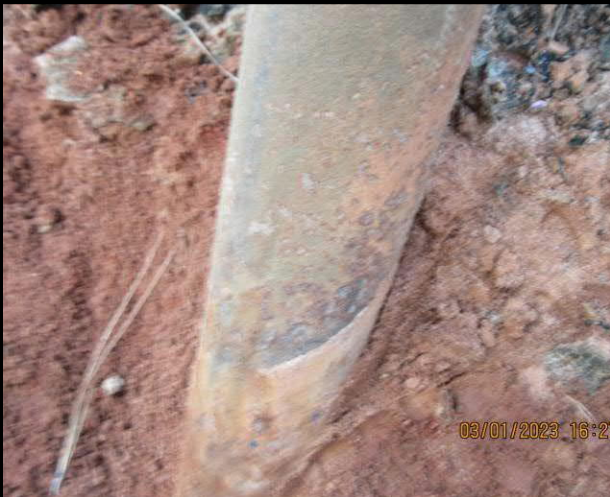
<p><u>I.3. Guy Mast Anchors (Anchor shaft condition below grade)</u></p> <p>Observation: Mild corrosion was observed on the anchor rod shaft at anchor CCC.</p> <p>Recommendation: Thoroughly clean all areas of corrosion and apply two coats of a cold galvanizing compound containing at least 95% zinc.</p>
